# TECHNICAL MEMORANDUM

| <b>Project</b> | Beleura Creek Path, Mornington | <b>Date</b> | 9 March 2022 |
| <b>Subject</b> | Geotechnical Inspection of Beleura Creek Path | <b>Ref No.</b> | V220152Letter01.1 |

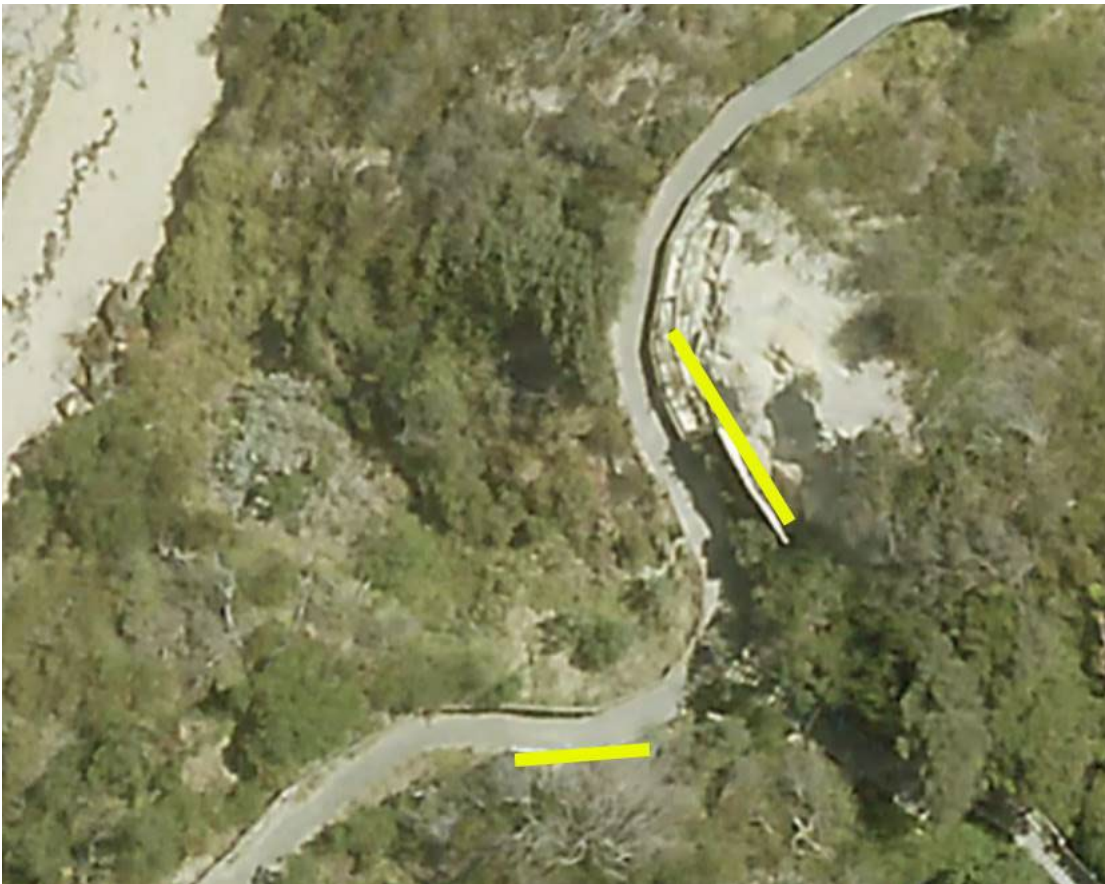
While a majority of the path was considered to be a low risk to the public, there was one section to the rear of 25-27 Kalimna Drive which is of particular concern.

The area lies on a bend in the path where the path follows the cliff into a small gully. In this area the cliff is very steep and there are areas where there is minimal vegetation and the underlying residual soils and weathered granite rock are exposed.

In recent times collapses of the cliffs have occurred at two locations resulting in debris from the cliffs falling onto the path. These locations are shown as yellow lines on the figure above.

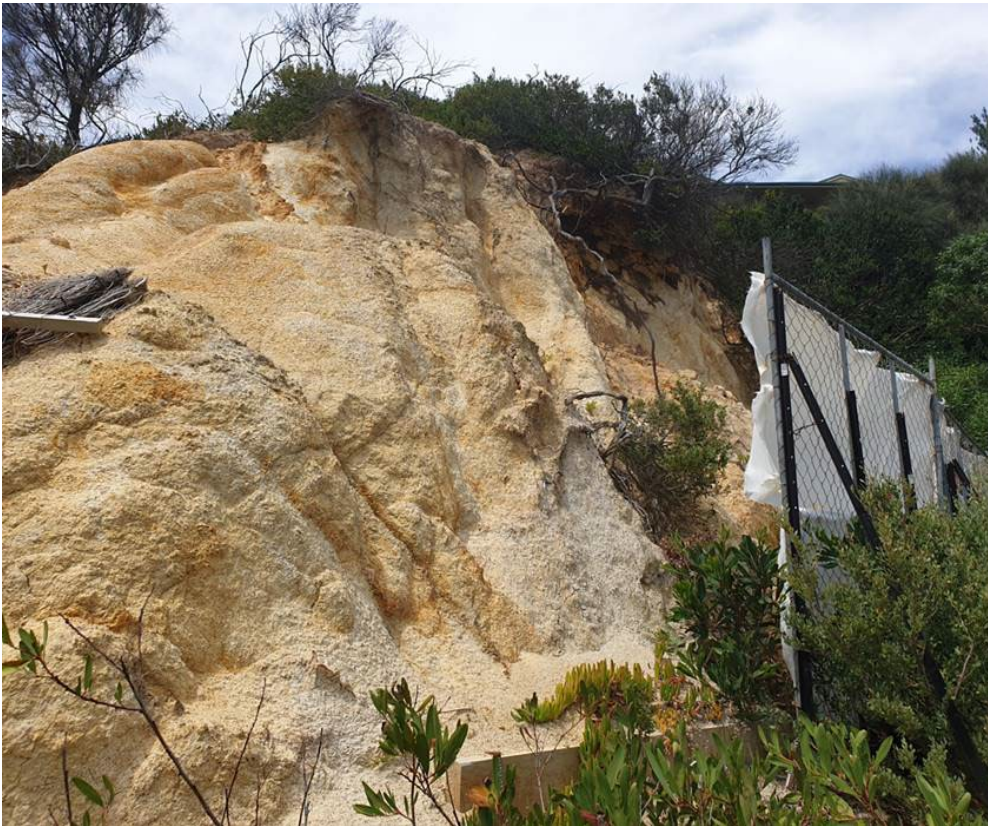
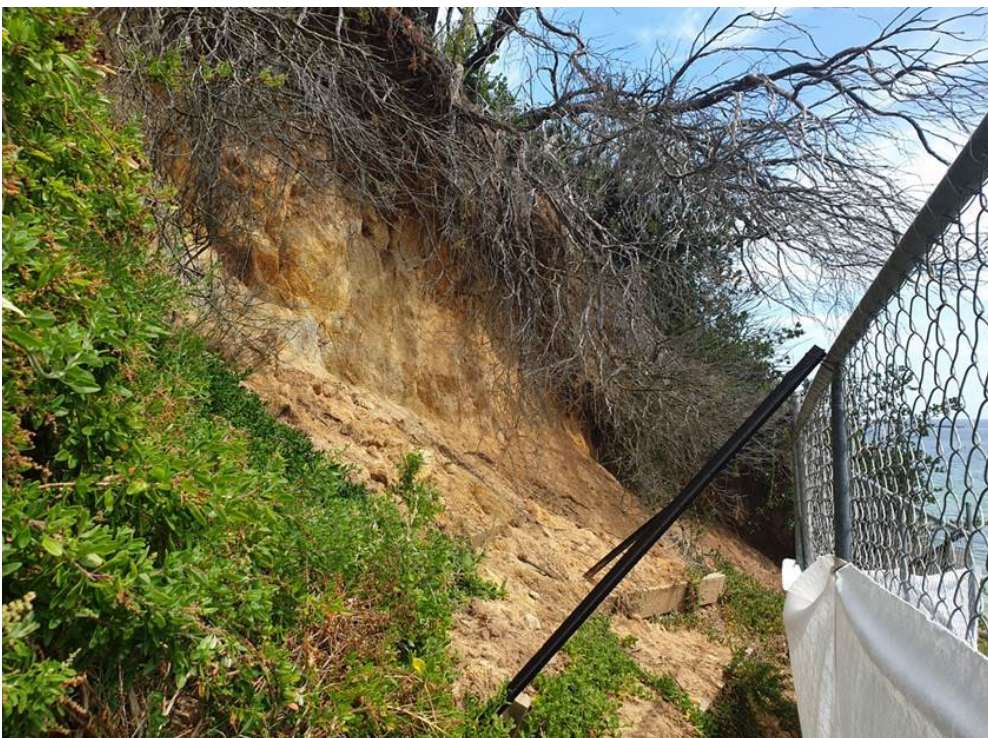
Photographs of the two sites are provided below. The first image is the northern cliff and the second image is the southern cliff.

While the overall cliff is likely to be relatively stable and have a tolerable risk due to the presence of weathered granite at shallow depth, weathering of the upper soil profile has resulted in collapses of the upper cliff.

These collapses in combination with heavy vegetation above the cliff have resulted in overhangs where significantly large bodies of soil are only being supported by the root structure of the vegetation.

It is considered likely that further collapses of these upper soils will occur in the relatively short term. As can be seen from the photographs, fencing has been installed to capture spoil falling from the cliff.

In the immediate future such fencing may provide some protection to the public from incidental small failures. However, as the fencing is not an engineer designed retention system any large failures are unlikely to be restrained by the existing fences.

As such it is considered that the risk to the public from a larger collapse of the upper cliff is not tolerable and a rehabilitation solution is required to reduce the immediate risk.

In order to reduce the risk it is recommended that the vegetation within 2m of the crest of the slope be removed. Any overhangs should then be removed and the upper 1m of cliff flattened back to a maximum slope of 1V:2H.

Provided that the works can be undertaken within the next few weeks then it is acceptable for the path to remain open. However, if the works cannot be undertaken in the next few weeks it is recommended that the path be closed until the works occur.

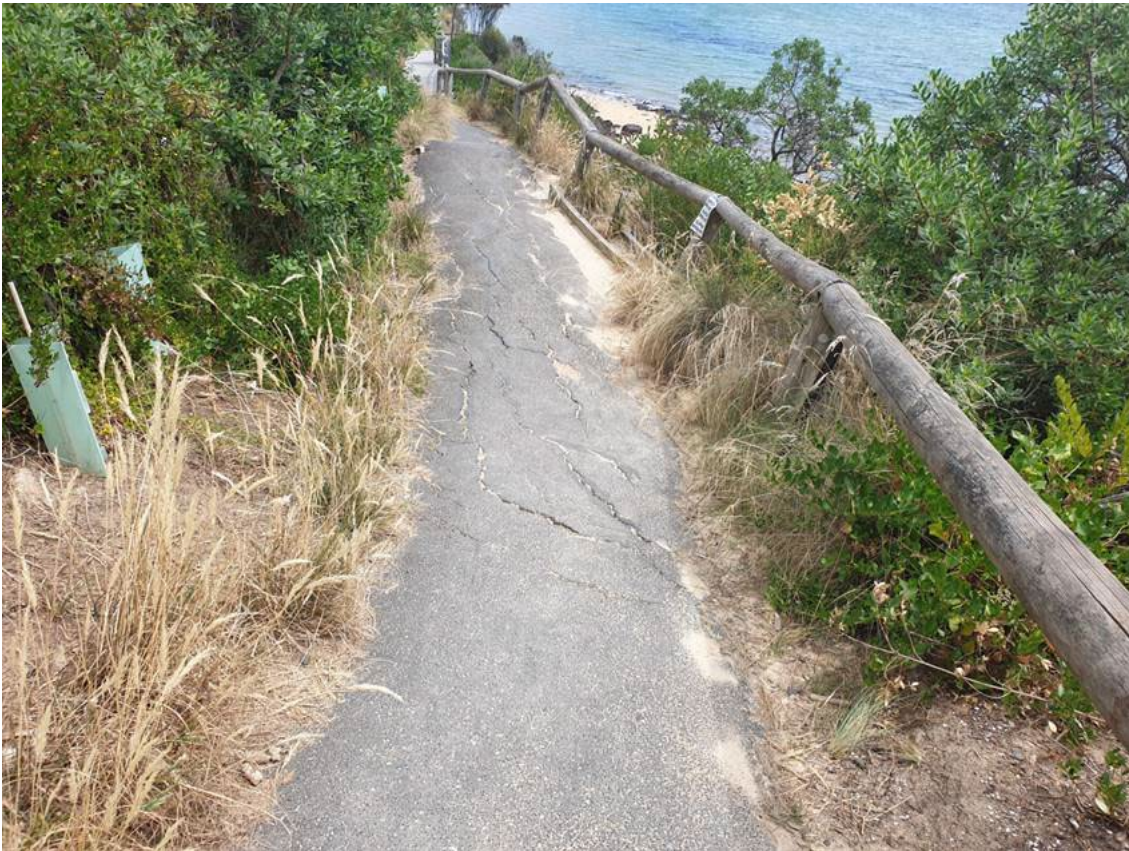
In addition to the above issue, it was observed that the path slightly down slope from the above area is showing signs of instability as shown in the following figure.

In this area there is significant cracking of the path as well as an arcuate depression potentially indicating the early signs of a failure of the cliff face below the path.

The hand rail was also in a loose condition.

While the immediate risk in this area is borderline tolerable there is potential for a failure to occur in the short to medium term. It is recommended that a series of monitoring points be installed to identify the rate of any movement that may be occurring.

In addition, it is recommended that the cracks be repaired and any drains be cleaned out to minimise the potential for water building up in this area.

It recommended that a formal risk assessment of the medium to long term risk be conducted for this area. Considering its proximity to the previous area discussed it is likely that any longer term solution would incorporate works for both sections of the cliff.
