Arthurs Seat Road  
Road Safety Assessment

| Document type | Existing Conditions |
| Project title | Arthurs Seat Road Road Safety Assessment |
| Report number | S20240449 |

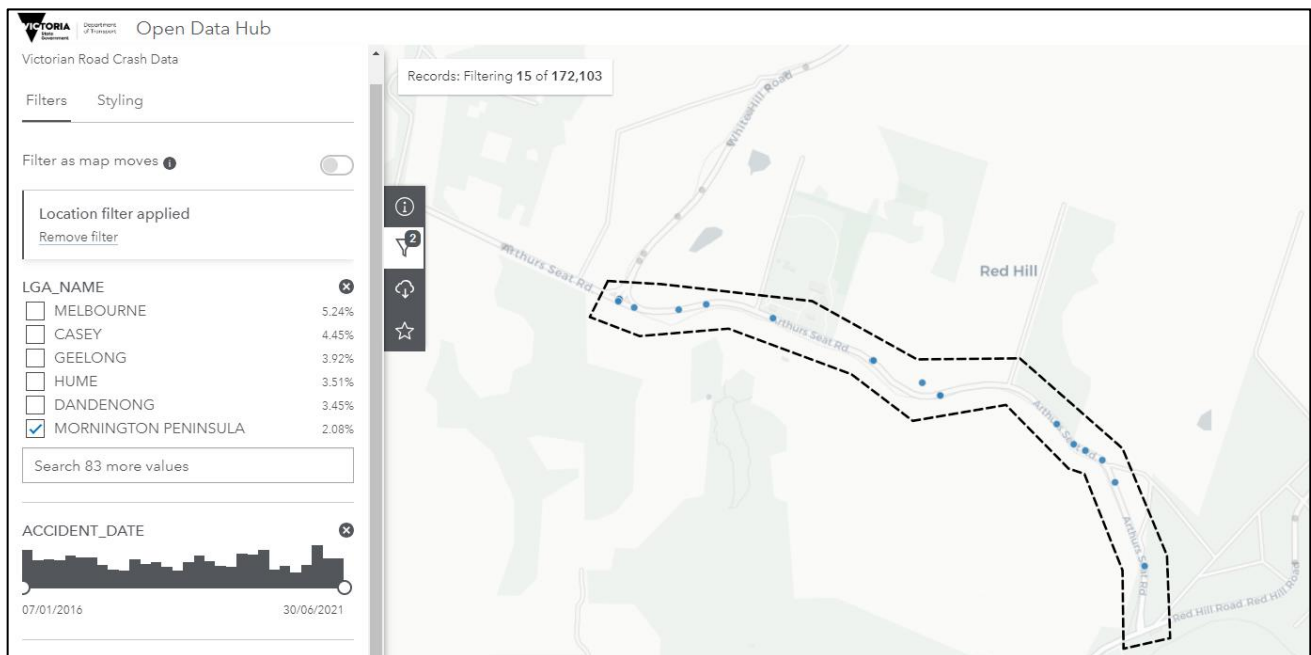
Figure 2 Crash data map

The authors of this document have conducted their own, independent crash query via the publicly available dataset (<https://discover.data.vic.gov.au/dataset/victoria-road-crash-data>). We have filtered crash data on Arthurs Seat Road between White Hill Road and Red Hill Road and found a total of 15 crashes, shown in Figure 2. A table excerpt of this data has also been provided in Figure 3.

- 4 of the crashes that have occurred in this section were run-off-road (loss of control) crash types.
- 6 of the crashes that have occurred in this section were at the intersection Arthurs Seat Road and White Hill Road.
  - 5 of these crashes have **not** been used / referenced as part of the Black Spot SAR. They were all intersection crash types.
  - The 1 crash that was used /reference as part of the Black Spot SAR was a head-on, serious crash

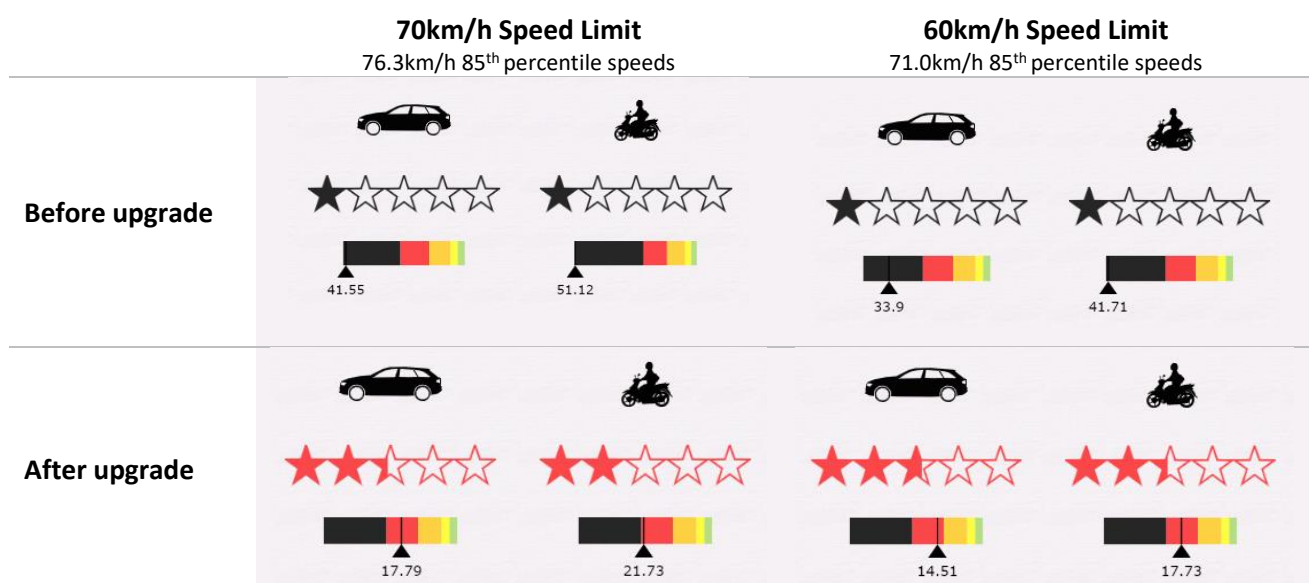
Figure 7 Before and after upgrade AusRAP Star Rating (Four scenarios)

The AusRAP assessment was not completed for each 100 m segment of Arthurs Seat Road but was rather a representative AusRAP assessment. Coding of road attributes was completed based on a representative cross section of the 'before upgrade' determined from supplied photographs, data and historical information available. The 'upgraded' was based on site inspection information at sites with the installation of the barrier systems. For completeness, four scenarios were assessed as represented below.

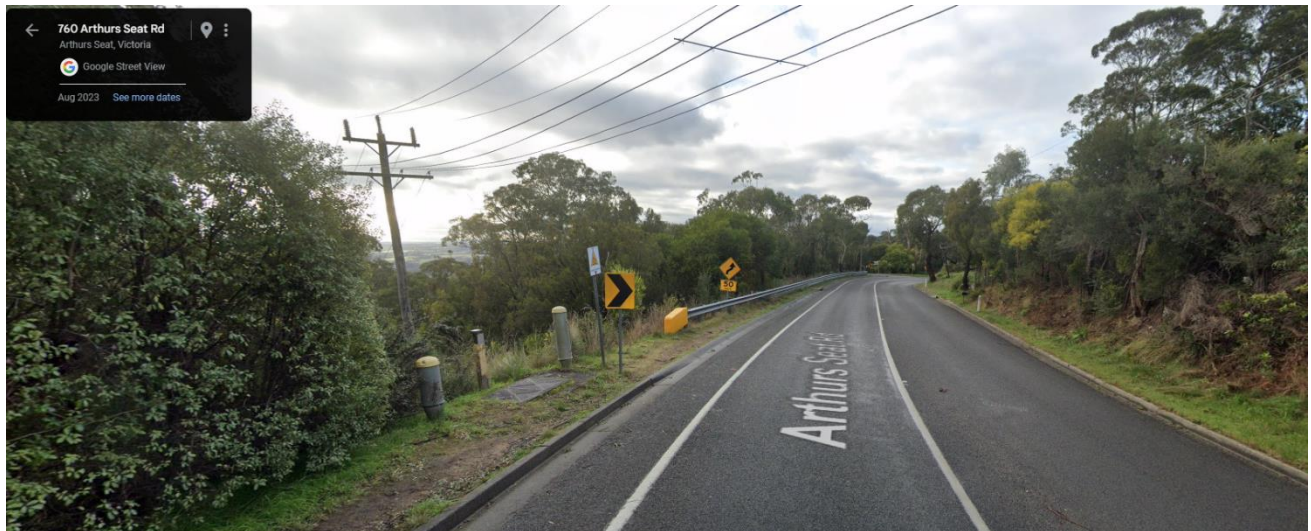
- 760 Arthurs Seat Road, Arthurs Seat

have had similar road safety treatments (barrier, underrun protections, curve warning signs, CAMs etc) implemented. A few examples have been provided below:
