# Further Information

## *The Pillars Long Term Management Plan*

# **THE PILLARS**

## **Community Workshop Findings Report**

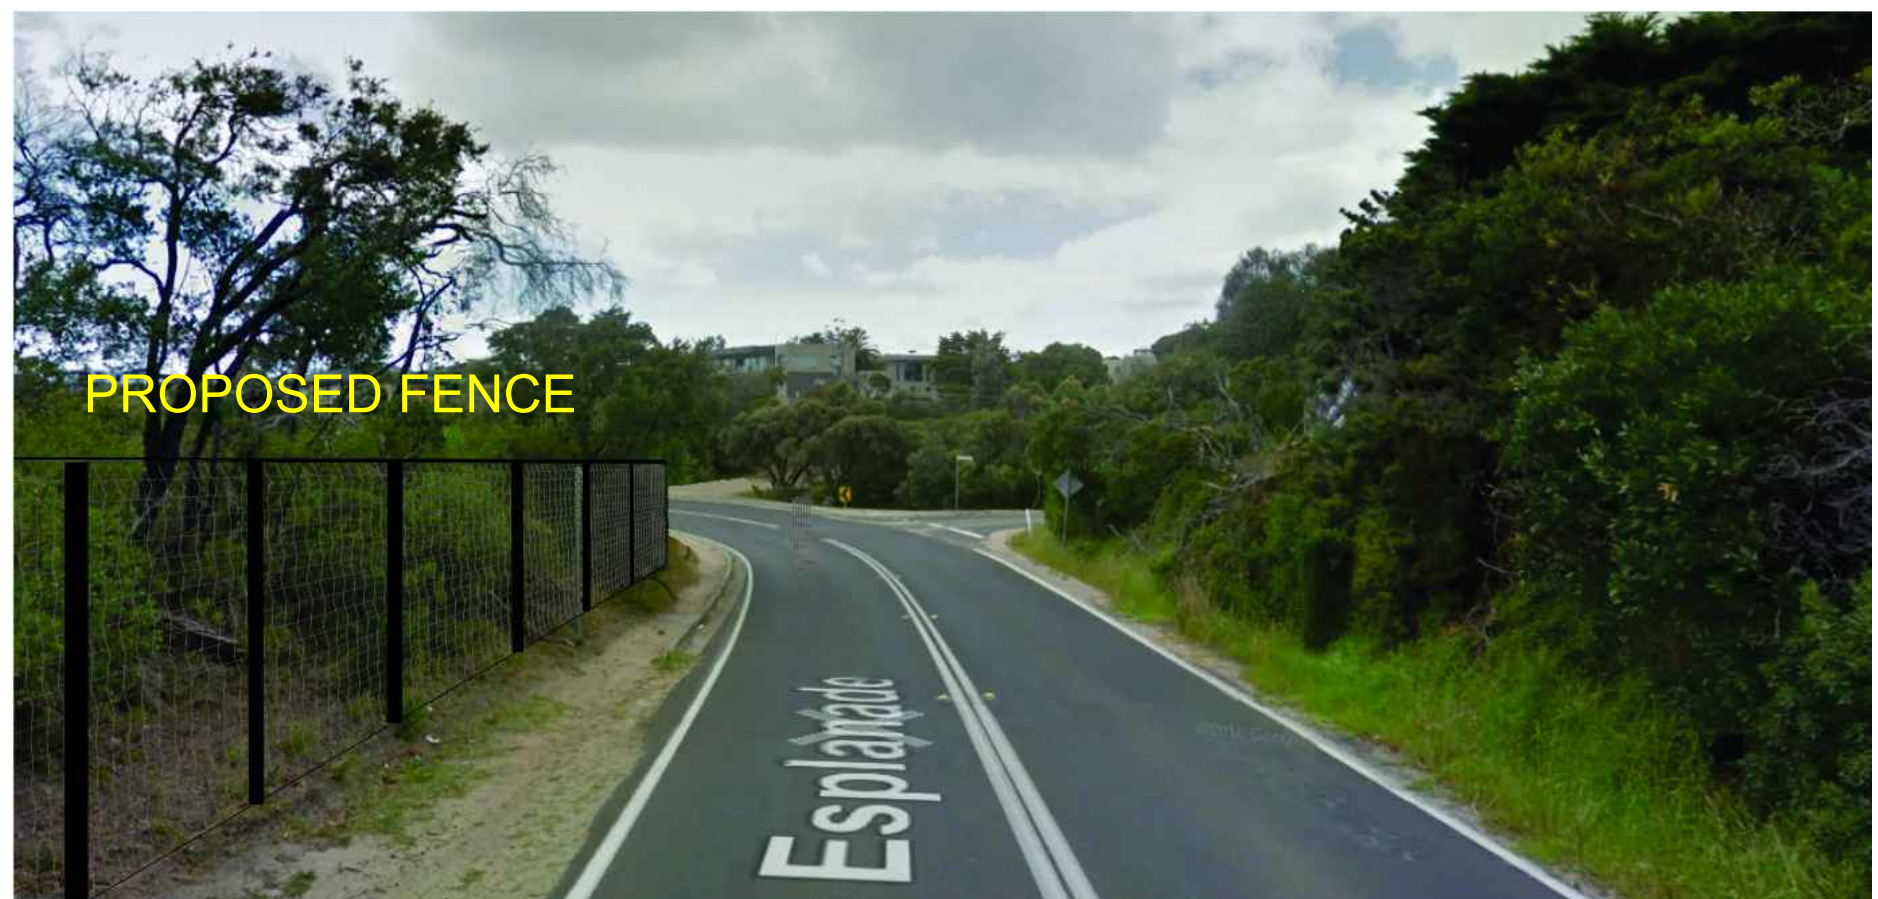
FENCE GRAPHIC SHOWN IS A REPRESENTATION ONLY AND IS NOT TO SCALE  
REFER TO CORROMESH FENCE ACTUAL PHOTO BELOW

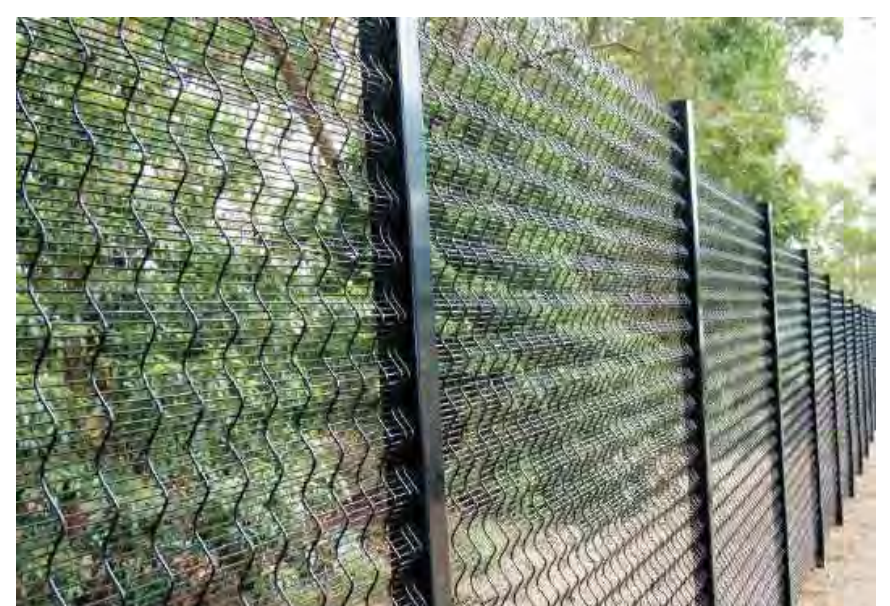
CORROMESH FENCE

FOOTING DETAIL  
to be confirmed

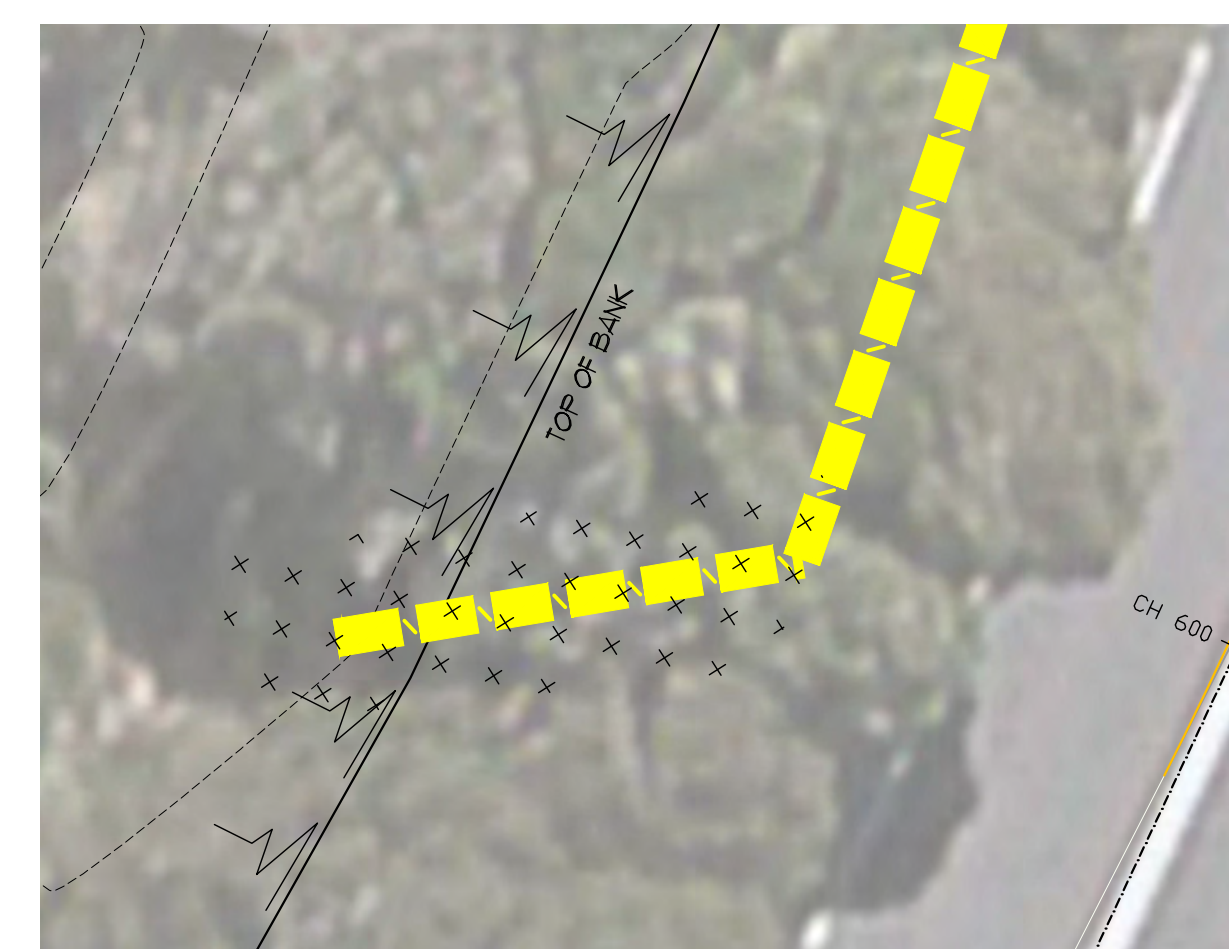
EXACT END POINT OF FENCE TO BE DETERMINED  
THROUGH DETAIL DESIGN.  
APPROX VEGETATION REMOVAL 1 METRE EACH SIDE  
OF FENCE

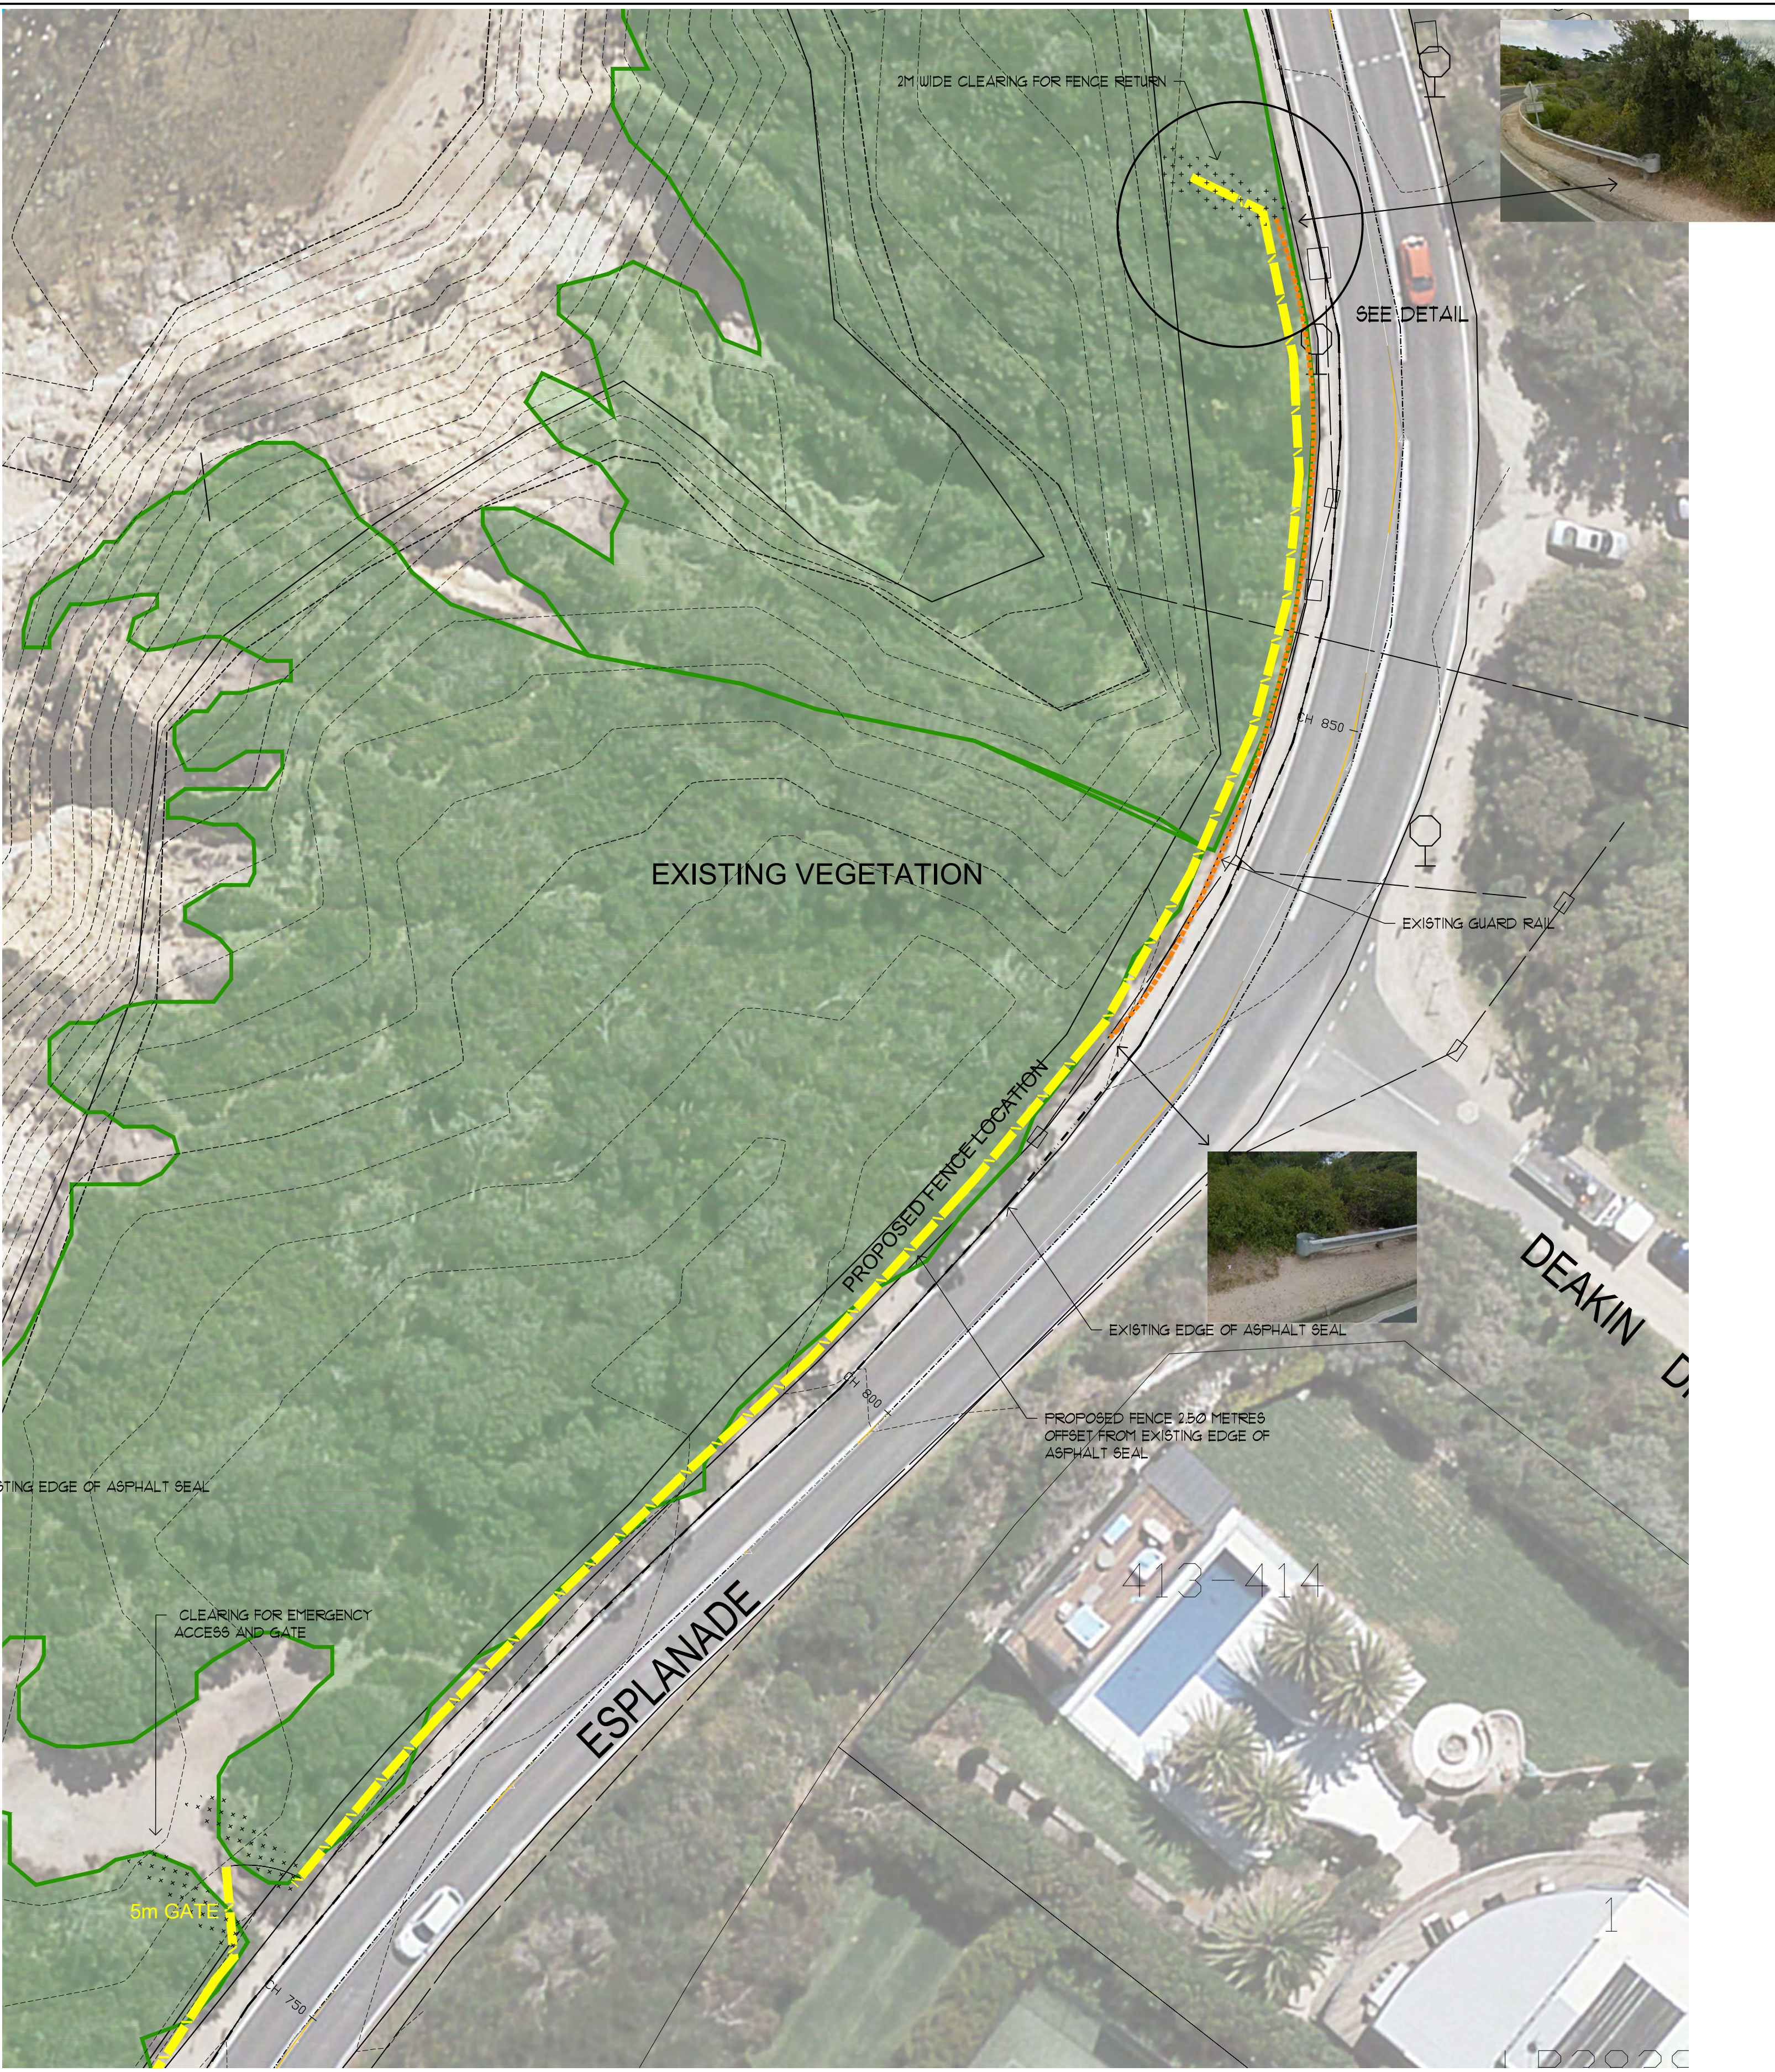
EXACT END POINT OF FENCE TO BE DETERMINED  
THROUGH DETAIL DESIGN.  
APPROX VEGETATION REMOVAL 1 METRE EACH SIDE  
OF FENCE

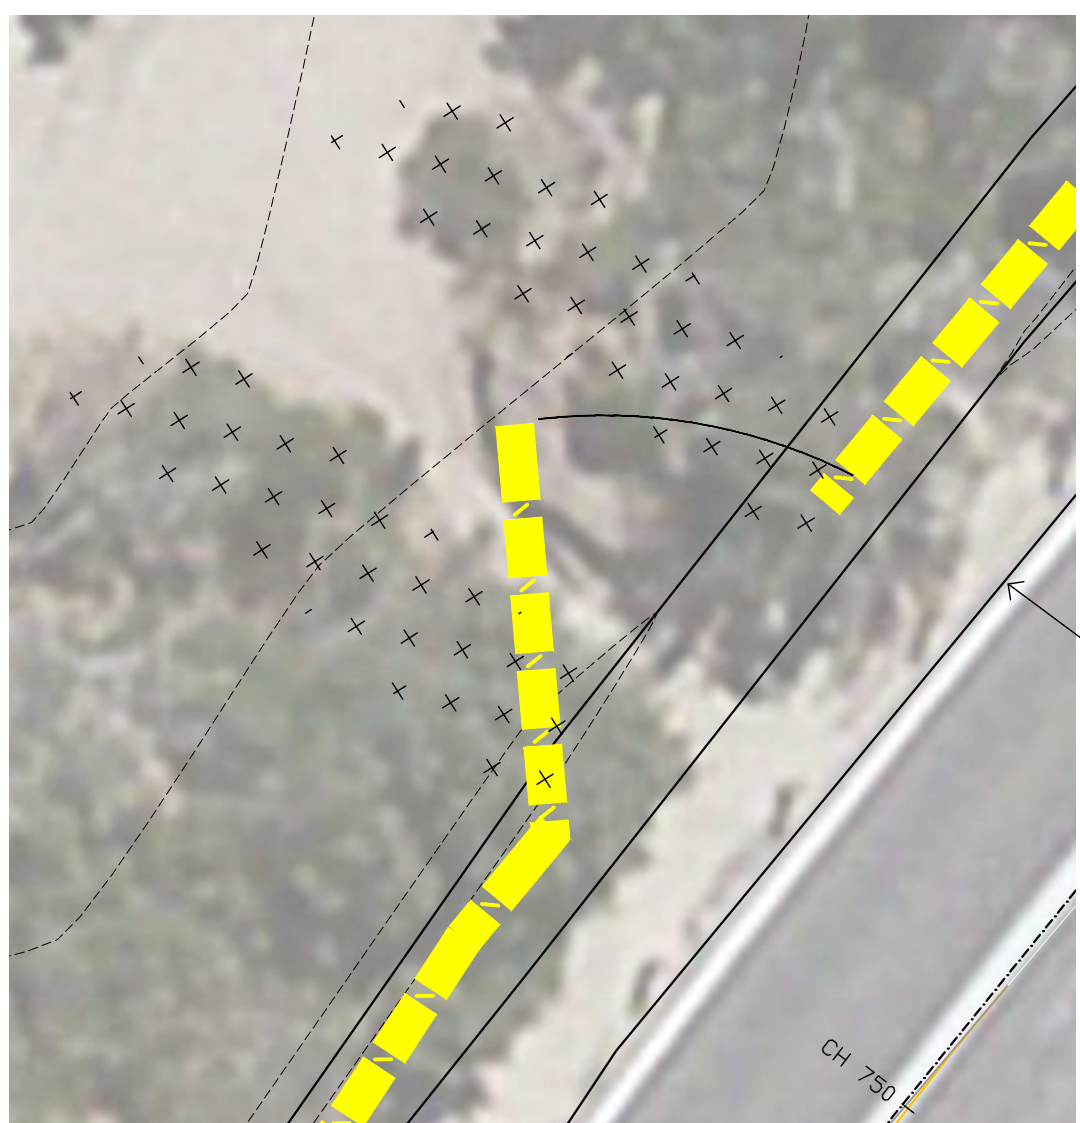
EXACT END POINT OF GATE TO BE DETERMINED  
THROUGH DETAIL DESIGN.  
APPROX VEGETATION REMOVAL TO PROVIDE  
A 5 METRE WIDE ACCESS PATH

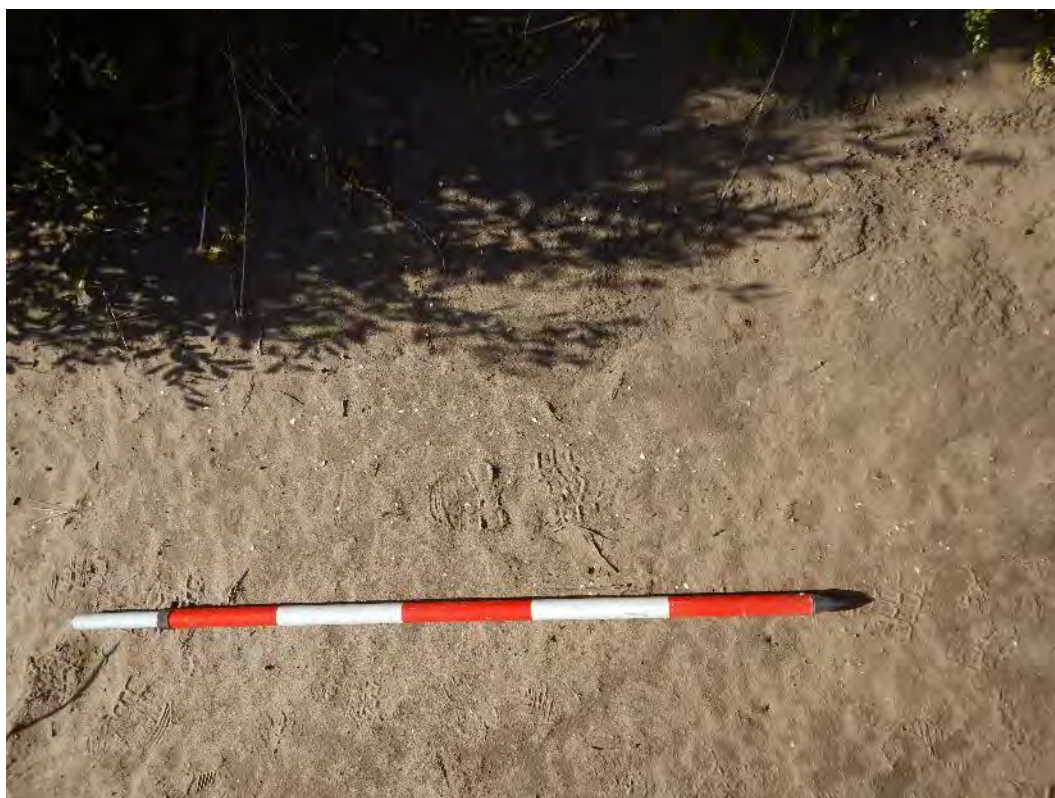
**Plate 1**     **Area of surface shell midden on exposed track**

Map 3). The surface shell midden within these areas is highly fragmented (Plates 1-3).

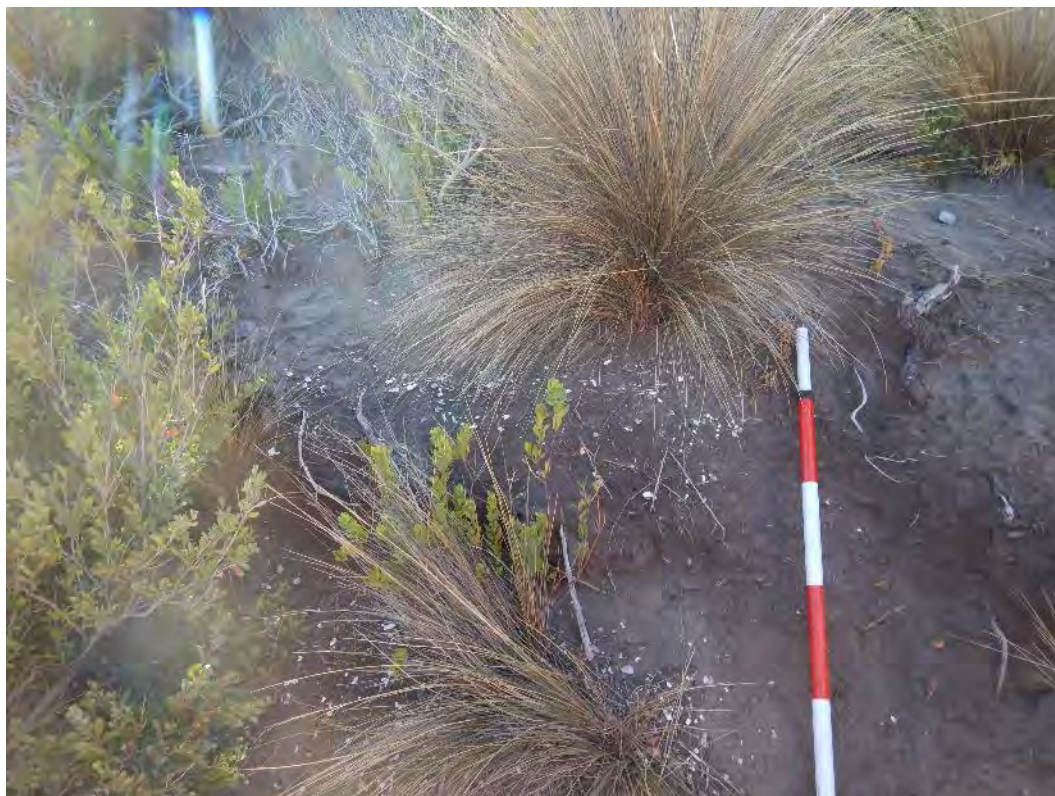
Dense lenses of in situ shell midden material is present within the coastal cliff edge section. These lenses range in depth between 5 to 30 centimetres (Plates 4-6). Charcoal is also present among the in situ shell midden material.

**Plate 4** Shell midden lense located in a west facing section approximately 5 metres from the coastal cliff edge

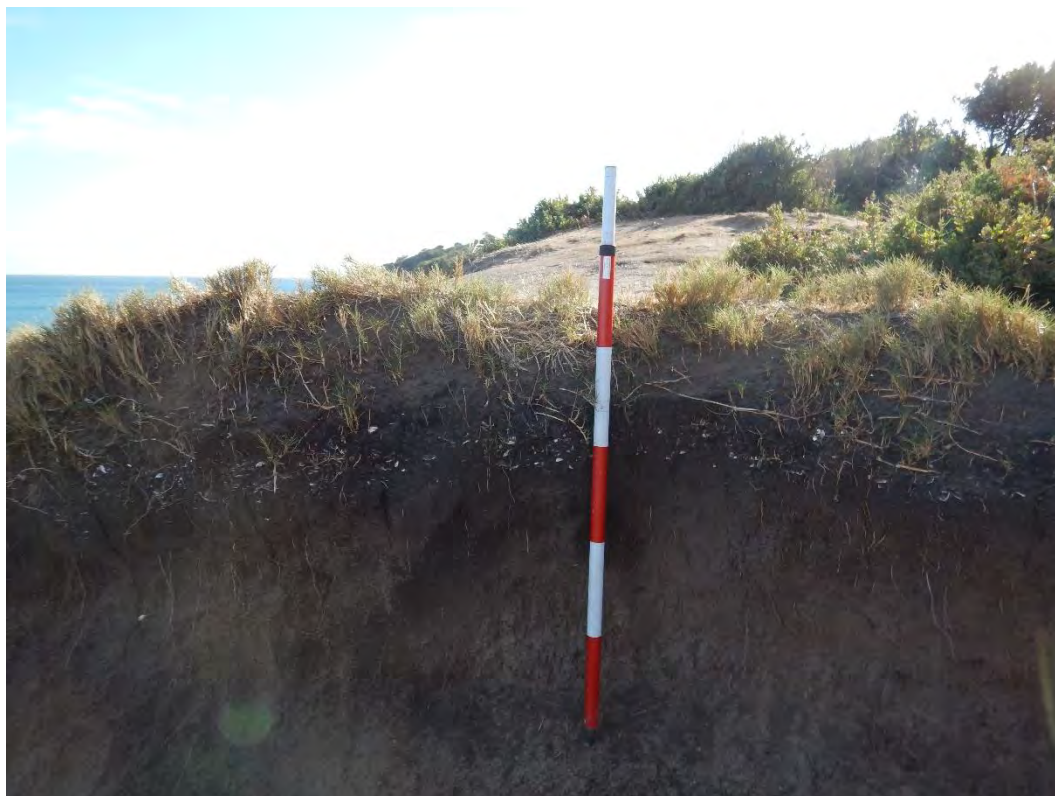
#### **Plate 6      Shell midden lense located in coastal cliff edge**

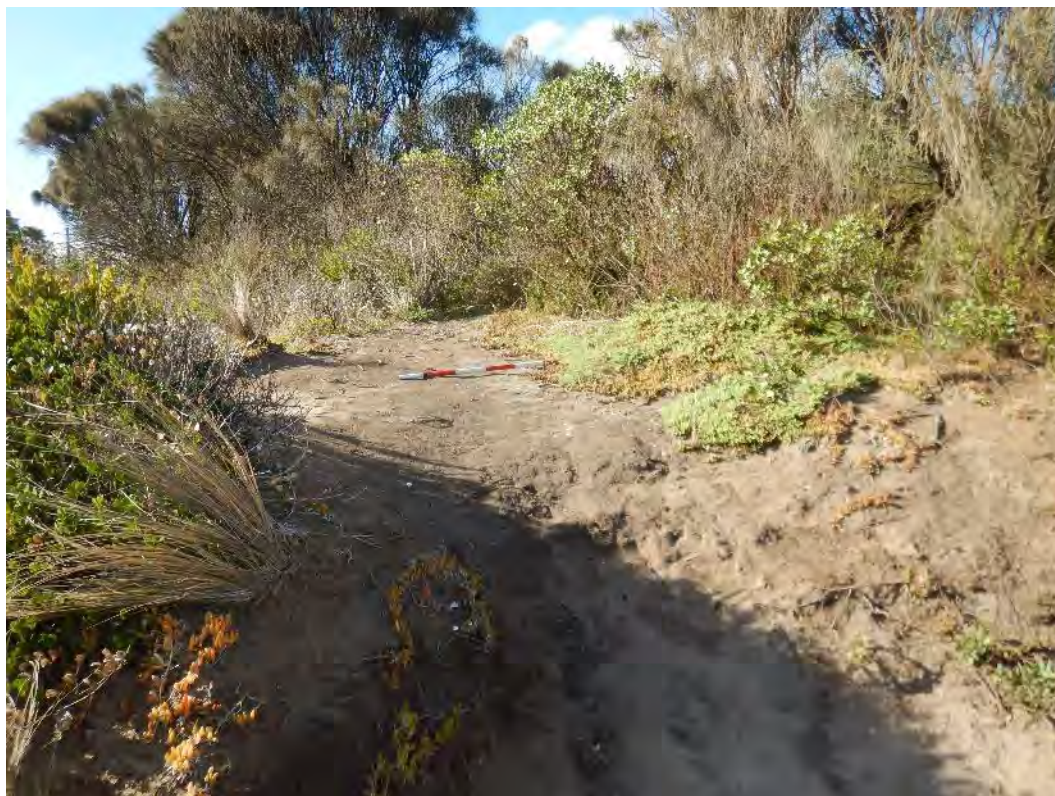
Overall, GSV in the Activity Area was poor. This was due to the low visibility of the ground by coastal vegetation. The ground surface was exposed in a few areas where foot traffic has exposed tracks through the vegetation. Exposed tracks offered the highest visibility (100%) while areas off to the exposed tracks were obscured by vegetation (0% visible) (Plates 7-9).

**Plate 7** Ground surface visibility on and off exposed track, looking east

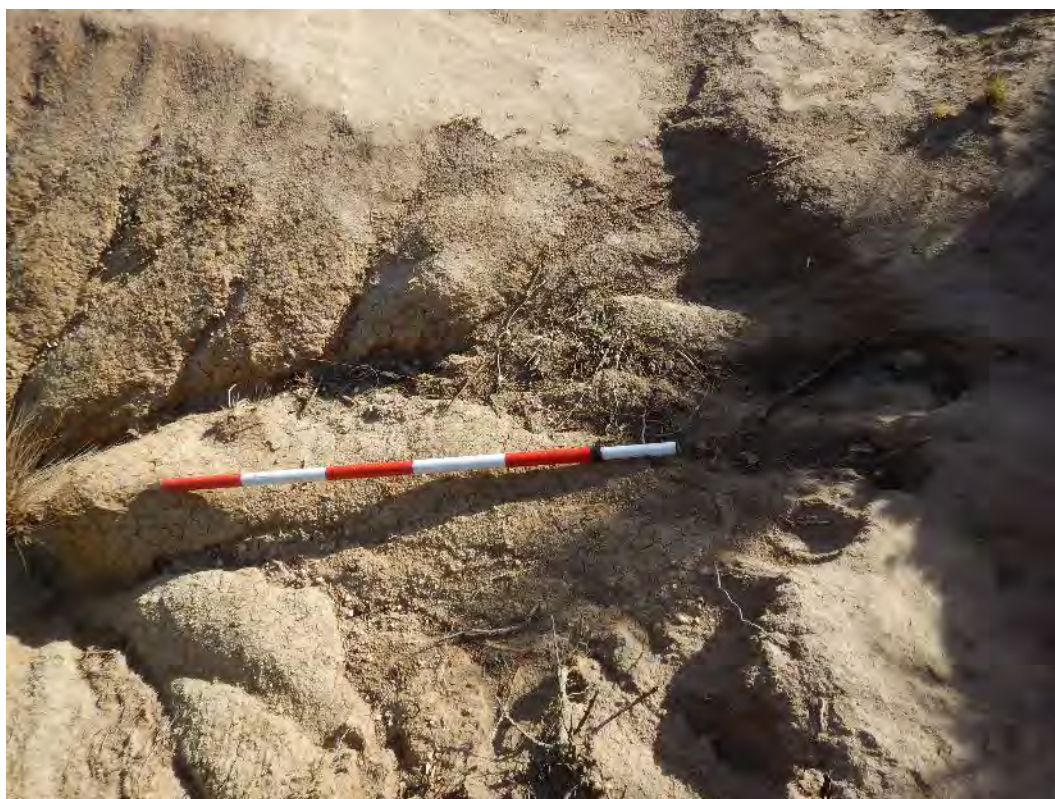
**Plate 8** Ground surface visibility in exposed track areas

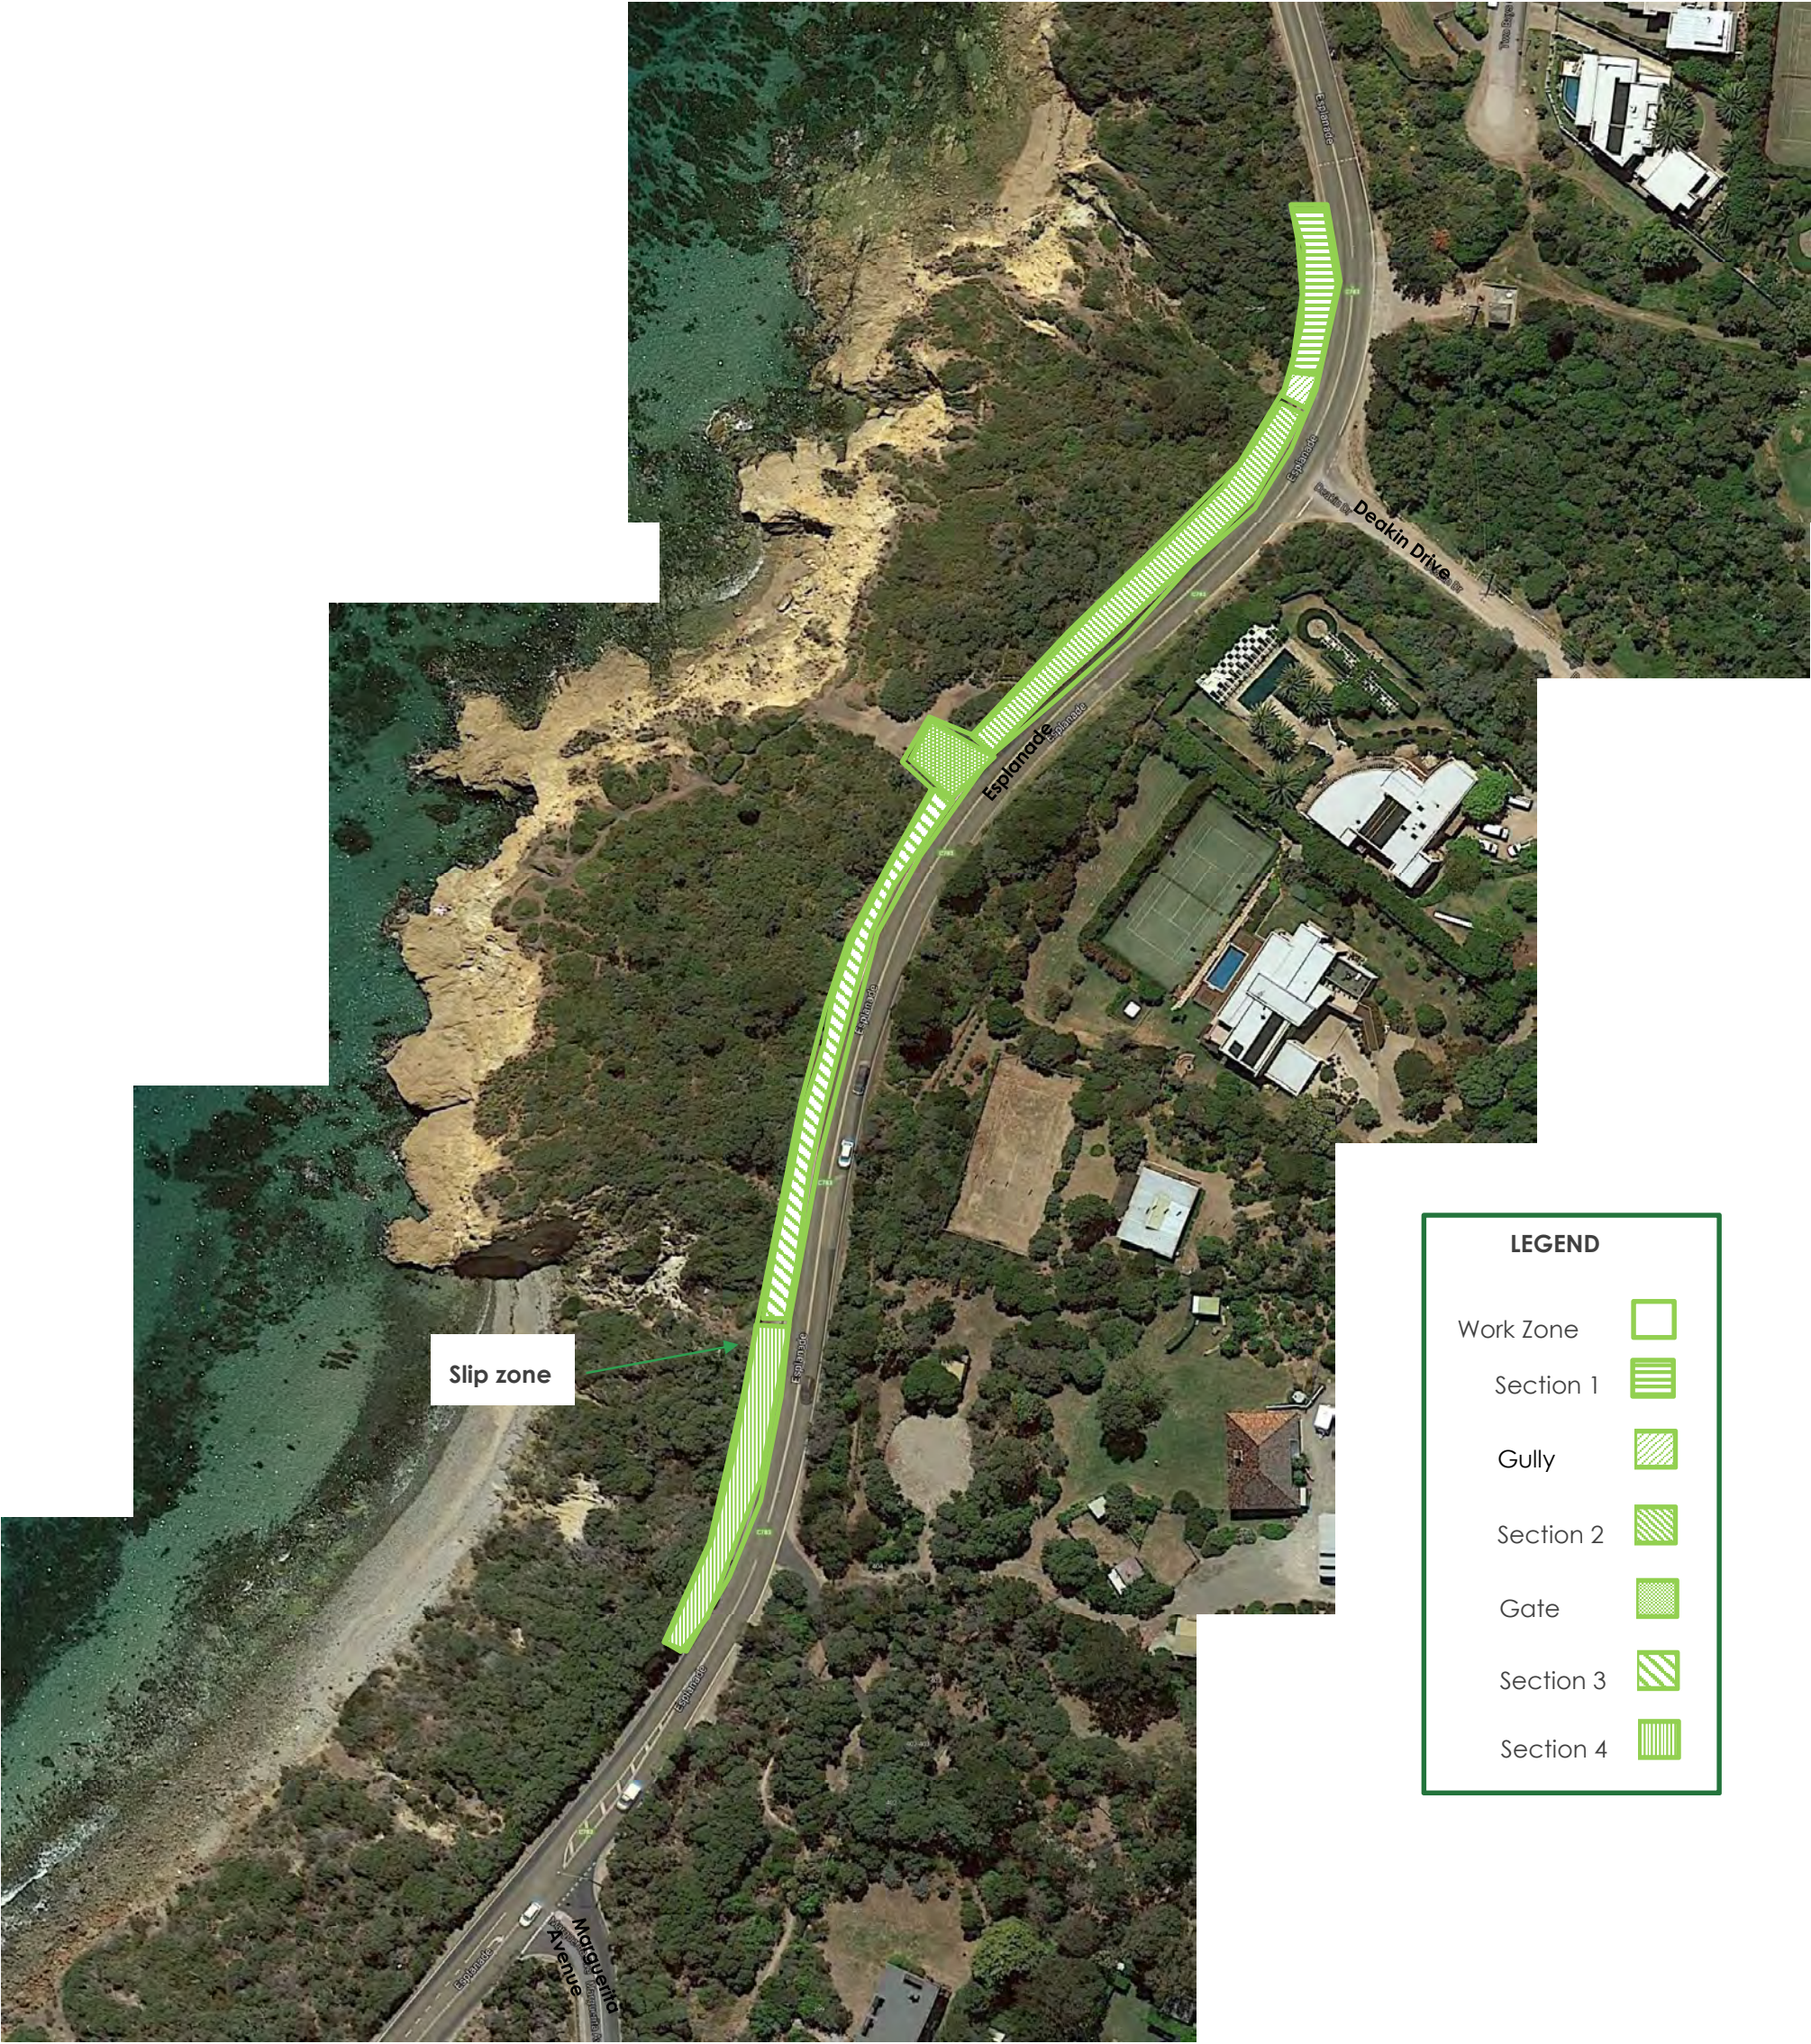
Figure 1 – Location of vegetation assessment area

An onsite visual inspection of the roadside vegetation was undertaken on the 22/05/17. The area inspected comprised of a length of roadside approximately 330m long and 5m wide (Figure 1). The width of the impacted area includes the setback of 2m from the road for the final position of the fence and a 3m clearance for the construction of the fence, with a total width of 5m.

Visual assessment of the vegetation within 5m of the road edge along the 330m site of the proposed construction of fence found a mix of introduced and indigenous species. There were eighteen indigenous species (Table 1) located along the length and seventeen introduced species (Table 2). The work zone could be broken up into six zones where there was a disconnect in the structure of the vegetation (Figure 1).

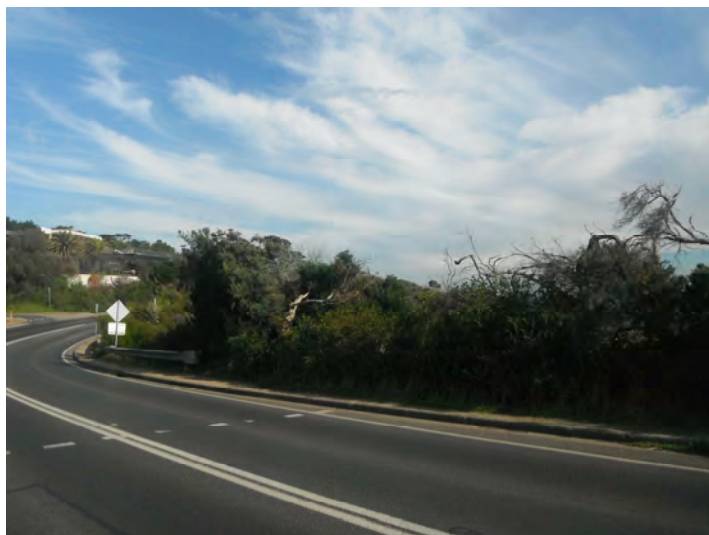
Figure 2 Vegetation at Section 1.

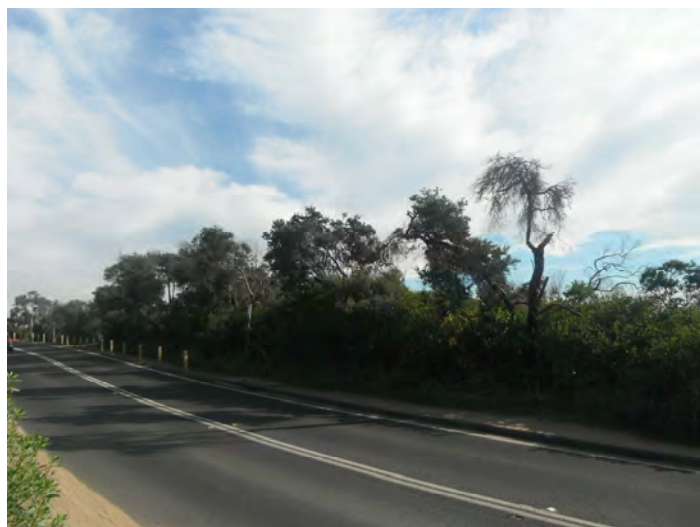
This section extended approximately 85m from the Gully to the location of the proposed gate (Figure 4). The weed species *P. myrtifolia* makes up the majority of the vegetation cover, followed by *C. monifera* and *A. longifolia* ssp *sophorae*. There are six mature *L. laevigatum* in this section, with a trunk diameter of approximately 25-30cm and a height of 3m. These trees make up a partial tree canopy cover in this section. While the *P. myrtifolia* is the dominant understory there are still some areas where the cover thins out and other indigenous species are found, these include *R. candolleana*, *P. poiformis*, *T. implexicoma*, the indigenous shrub species *Leucopogon parviflorus* (Coast Beard-heath) and the indigenous ground cover *Disphyma crassifolium* (Rounded Noon-flower). The clearing of woody species along the road side has aided in the establishment of a thin strip of indigenous and introduced ground flora along the road edge.

Figure 4 Vegetation at Section 2

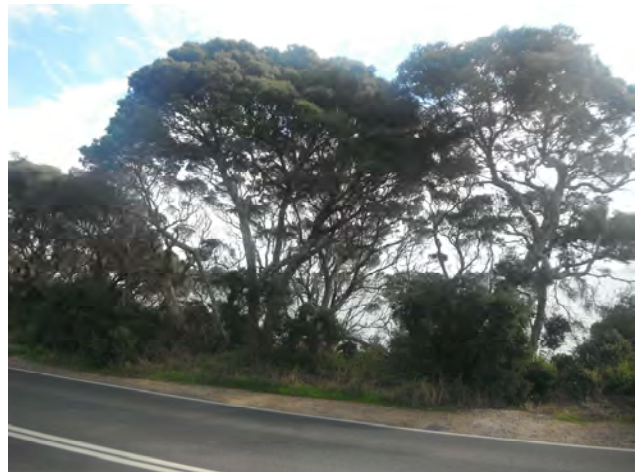
This section extends from the slip zone to the end of the assessment site (Figure 7). The canopy tree *Melaleuca lanceolata* (Moonah) starts to occur in this zone, with fourteen individual trees located with a trunk diameter ranging from 20-46 cm. While there were still a fair cover of *P. myrtifolia*, especially in any larger gaps between trees where other weeds species were also found, such as *Pittosporum undulatum* (Sweet Pittosporum), it was not as dominant as in other sections of the vegetation assessment area. Under the *M. lanceolata* the species is a mix of *R. candolleana* and *L. parviflorus*. Other indigenous species included *Allocasuarina verticillata* (Drooping She-oak), *L. laevigatum*, *A. longifolia* ssp *sophorae* and *C. microphylla*.

Figure 7 Vegetation at Section 4

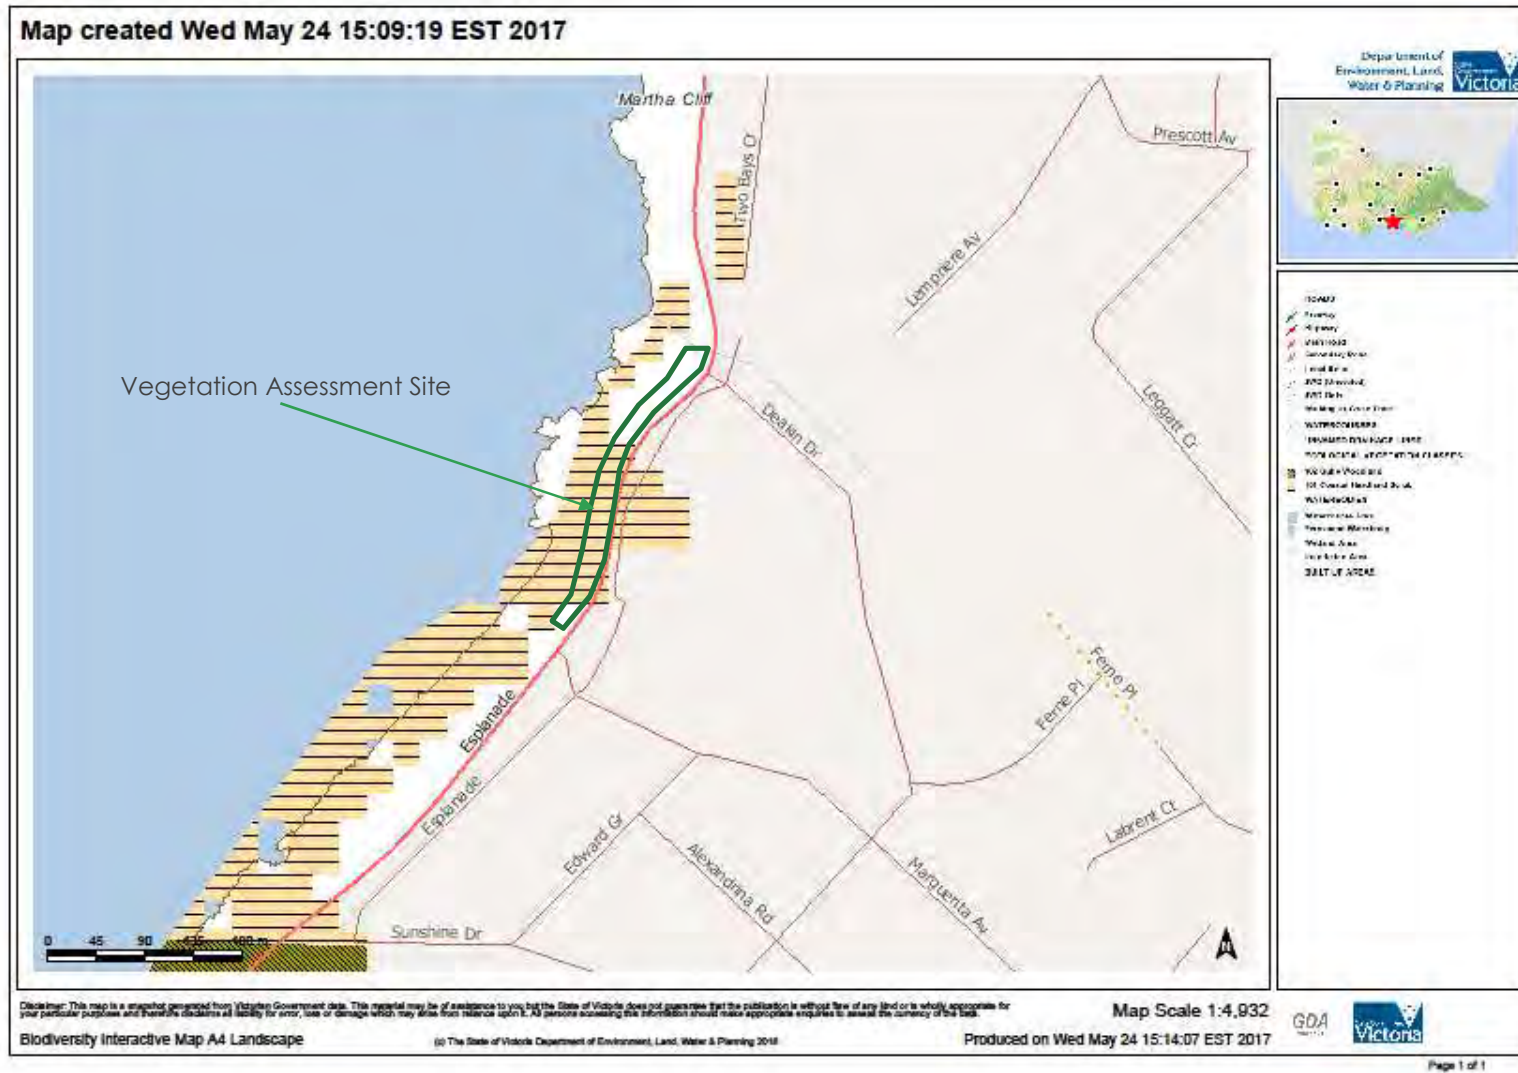
Figure 9 – 2005 spread of EVC 161: Coastal Headland Scrub within Vegetation Assessment site

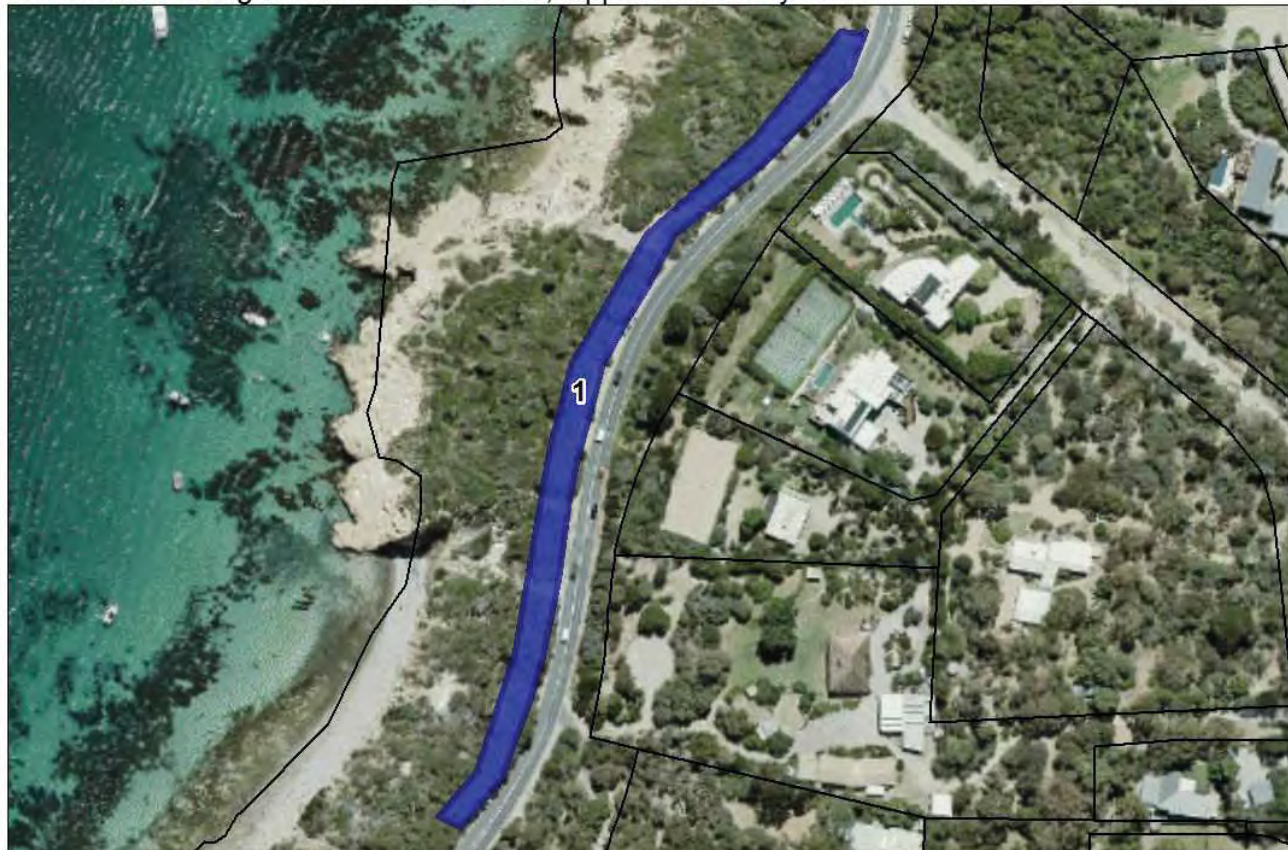
Marked native vegetation to be removed, lopped or destroyed

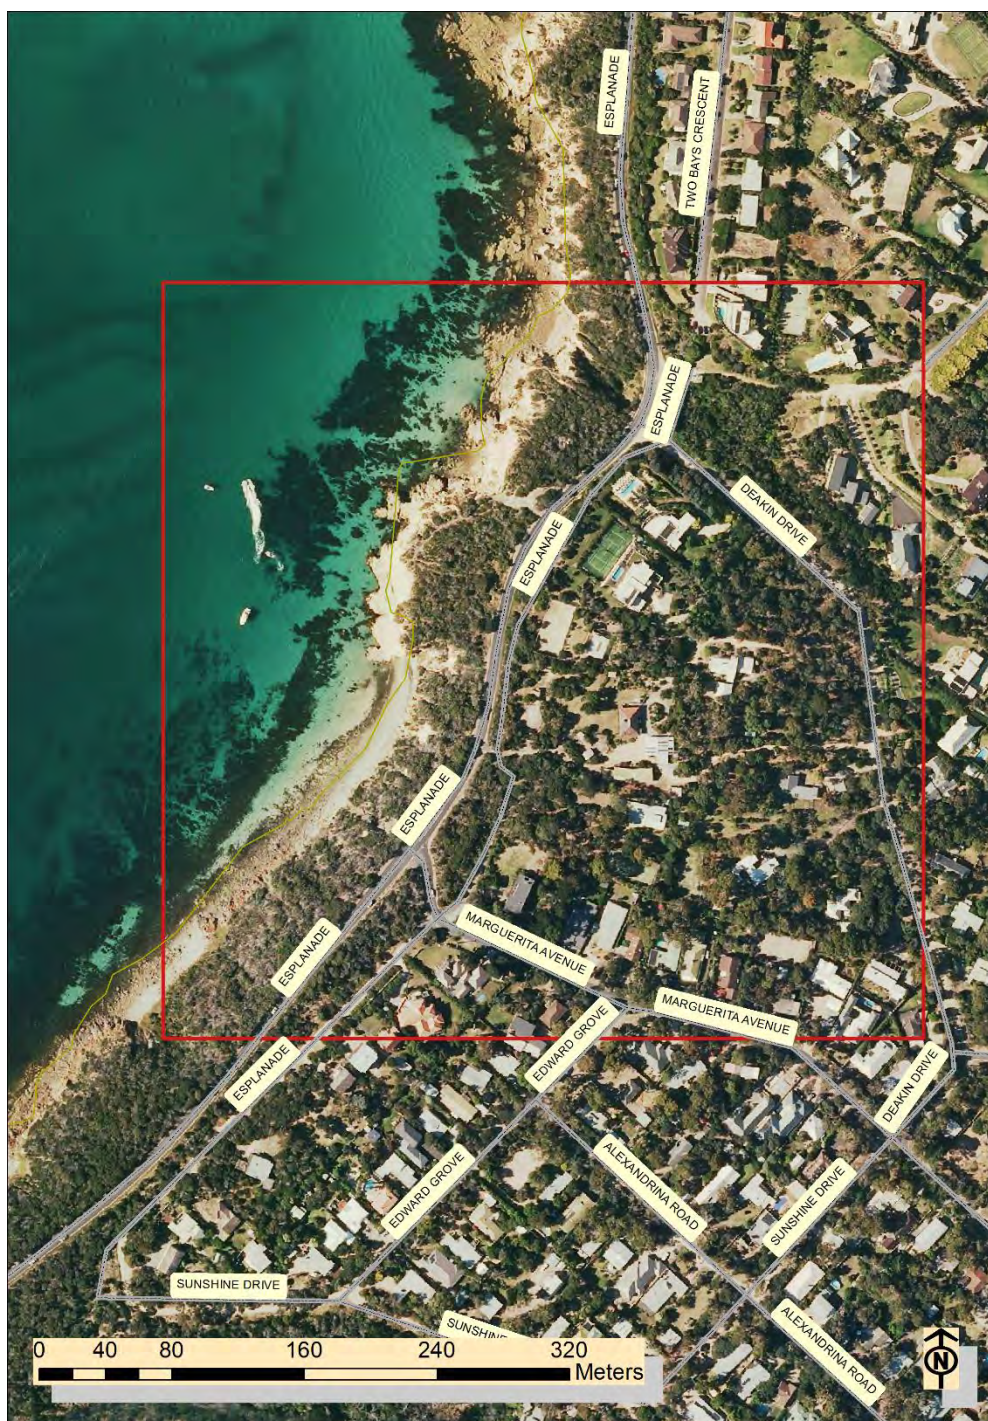
Figure 2 - Aerial view of 'Pillars' assessment area

The site was assessed on foot with a GPS enabled camera. Observations were taken in reference to the requirements defined by MPS. That is, the specific Pillars site was observed, which included the rocky platform, clifftop and undefined pathways leading to the site, and the section of the Esplanade running between Deakin Drive to the north and Marguerita Avenue to the south of the site, where the majority of visitors park.

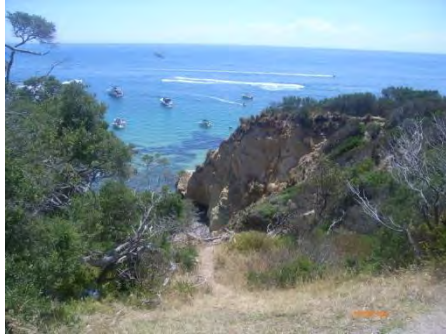
Observation 1 – Access path leading to the cliff edges at The Pillars. From observation this is considered an undefined access point.

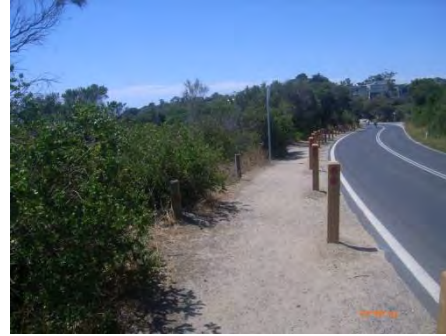
Observation 2 – One of the areas off the Esplanade where the pedestrian pathway along the road shoulder can facilitate two-way pedestrian access.
