# Further Information

## *The Pillars Long Term Management Plan*

# **THE PILLARS**

## **Community Workshop Findings Report**

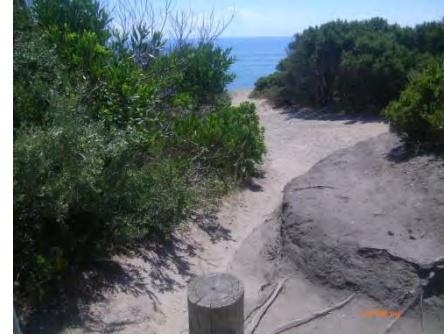
Observation 3 – An access point leading to the cliff edges. The access track has an inconsistent width and sloped edges providing an uneven surface.

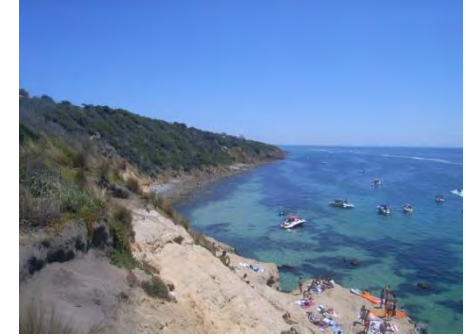
Observation 4 – Cliff top view highlighting the elevation of the cliffs in relation to the water.

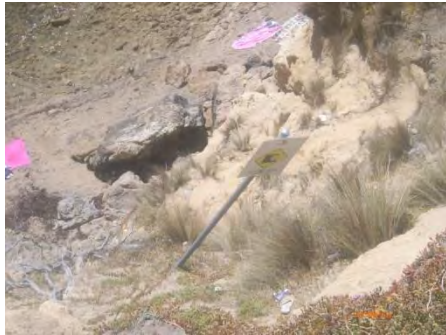
Observation 5 – View of beware unstable cliff hazard sign that has succumbed to the eroding cliff face.

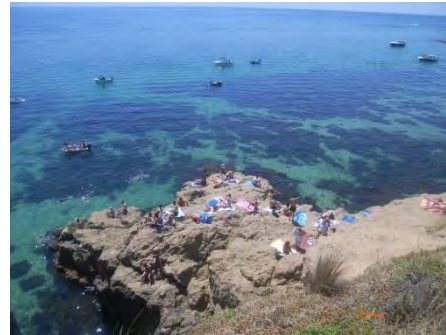
Observation 6 – Cliff edge view highlights the popularity of the site in terms of nearby boat moorings and active and passive bathers.

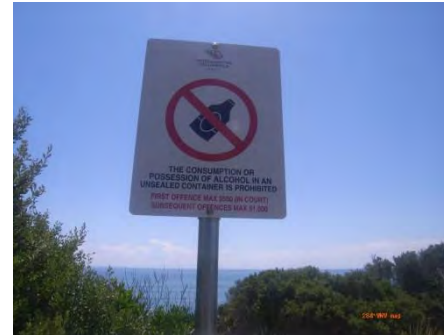
Observation 7 - Existing prohibition signage at The Pillars regarding consumption of alcohol.

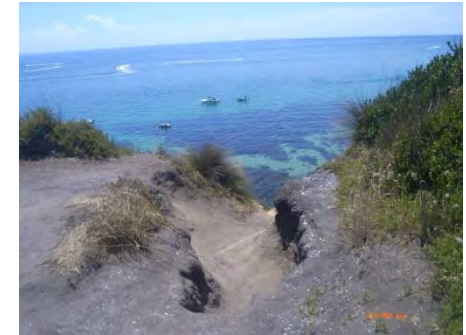
Observation 8 – Uneven, unstable and steep access down the lower cliff platforms at The Pillars.
