## ARBORICULTURAL IMPACT ASSESSMENT

Site address  
5 THE GLEN, RYE 3941

Prepared 31 March 2026

Assessment (AIA) and Tree Protection Plan (TPP) for the proposed construction of a new residential dwelling at 5 The Glen, Rye. The site is subject to the provisions of the Mornington Peninsula Planning Scheme, including the Vegetation Protection Overlay – Schedule 1 (VPO1) and Clause 52.37 – Canopy Trees.

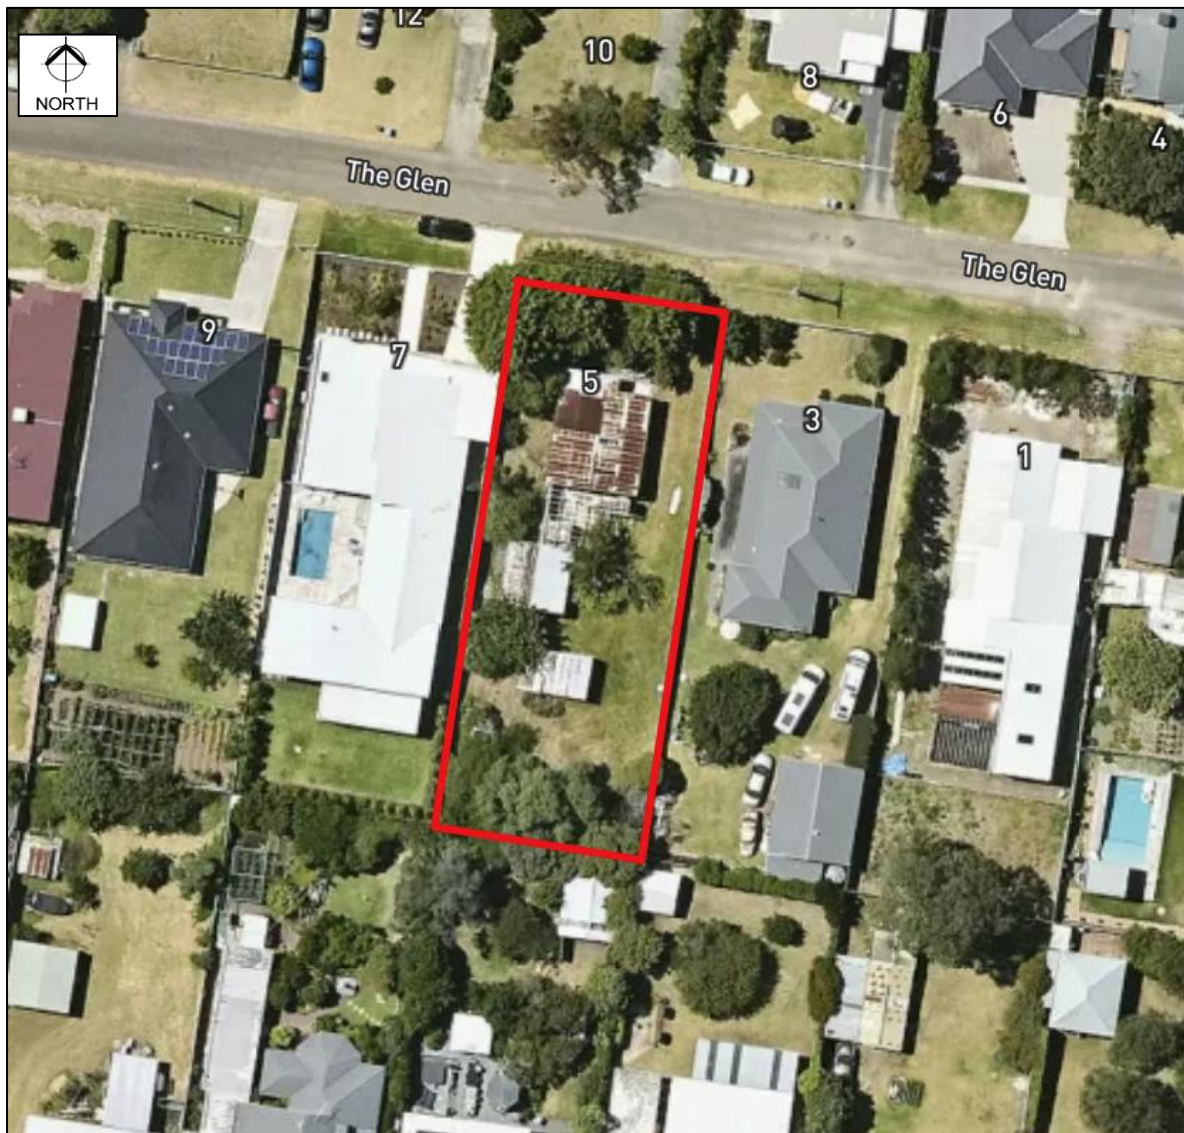
Figure 1. Aerial MetroMap image dated 29 December 2025.

A current aerial image of the site (Figure 1) is provided below to illustrate the existing vegetation distribution, surrounding residential context, and the established garden setting (Please note the previous dwelling and associated structures have since been demolished).

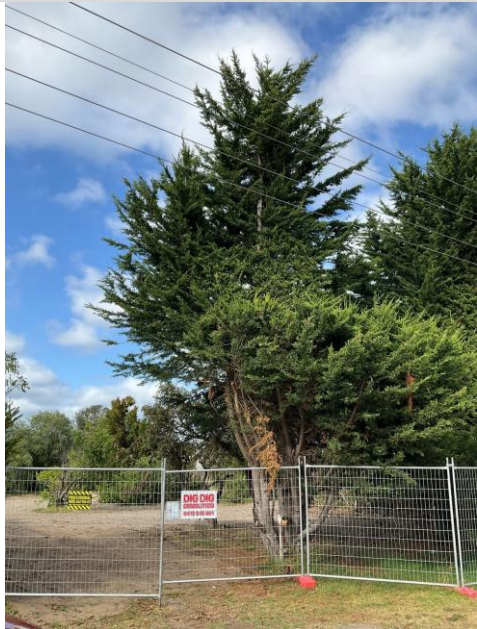
| Tree Number | 1 | Medium Retention Value |

| Tree Number | 1 | Medium Retention Value |
|---|---|---|
| Genus/Species | <i>Cupressus macrocarpa</i> | |
| Common Name | Monterey Cypress | |
| Nominated for removal. | | |

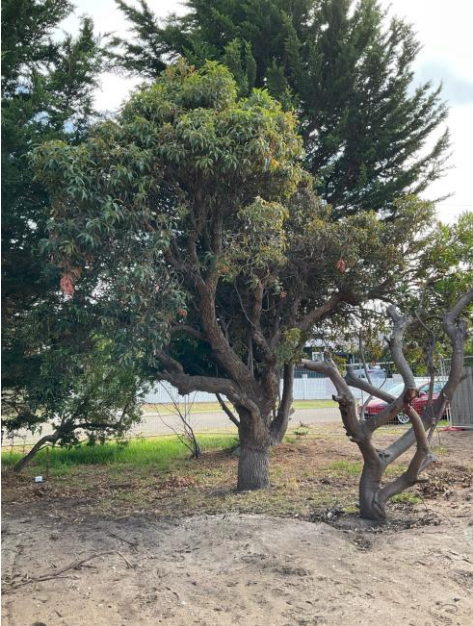
| Tree Number | | 2 | Low Retention Value |

| Tree Number | | 2 | Low Retention Value |
|---|--|---|---|
| Genus/Species | | <i>Corymbia ficifolia</i> | |
| Common Name | | Red Flowering Gum | |
| Nominated for removal. | | | |

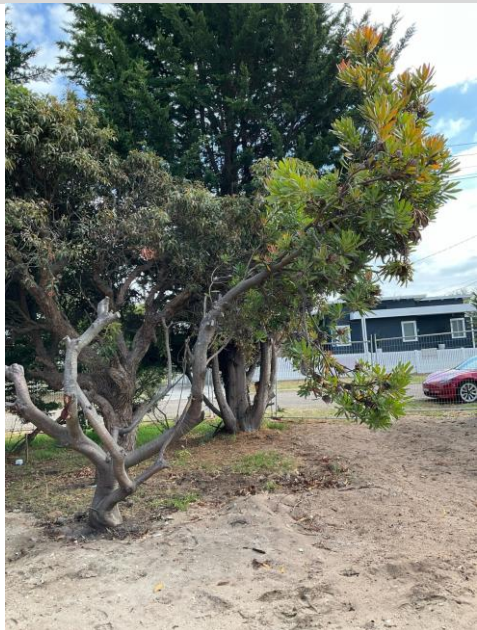
| Tree Number | | 3 | Low Retention Value |

| Tree Number | | 3 | Low Retention Value |
|---|---|---|---|
| Genus/Species | Protium sp. | | |
| Common Name | Protium | | |
| Nominated for removal. | | | |

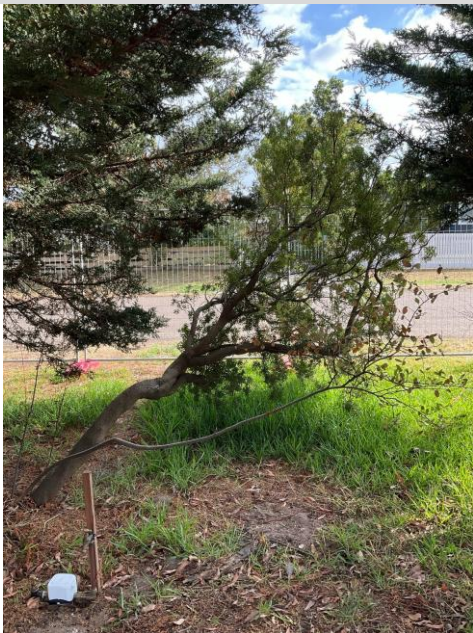
| Tree Number | | 4 | Medium Retention Value |

| Tree Number | | 4 | Medium Retention Value |
|---|---|---|---|
| Genus/Species | Leucopogon parviflorus | | |
| Common Name | Coast Beard-heath | | |
| No developmental impact. | | | |

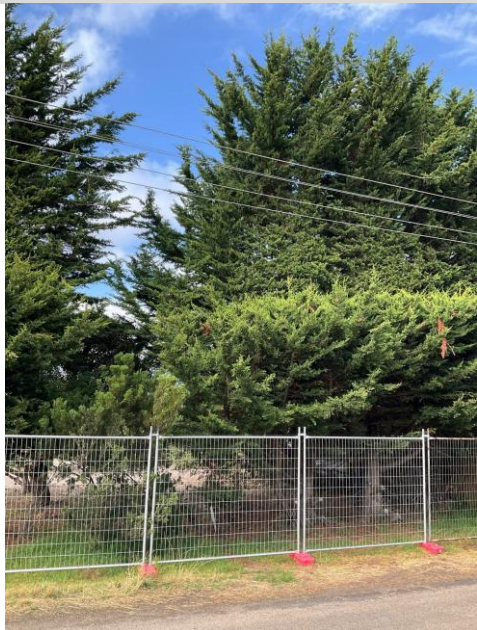
| Tree Number | | 5 | Medium Retention Value |

| Tree Number | | 5 | Medium Retention Value |
|---|--|---|---|
| Genus/Species | | <i>Cupressus macrocarpa</i> | |
| Common Name | | Monterey Cypress | |
| No developmental impact. | | | |

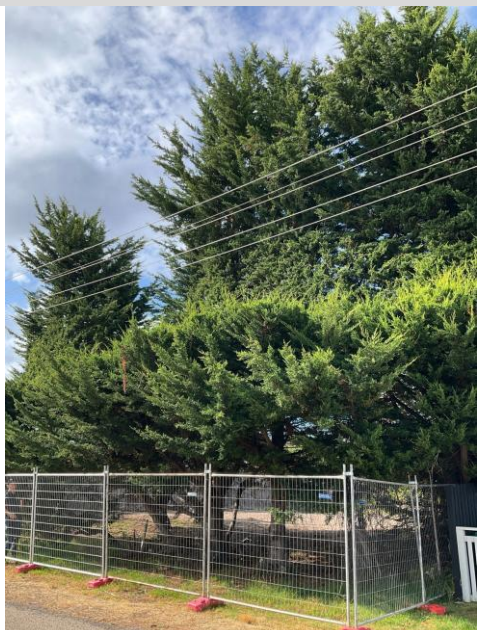
| Tree Number | | 6 | Medium Retention Value |

| Tree Number | | 6 | Medium Retention Value |
|---|--|---|---|
| Genus/Species | | <i>Cupressus macrocarpa</i> | |
| Common Name | | Monterey Cypress | |
| No developmental impact. | | | |

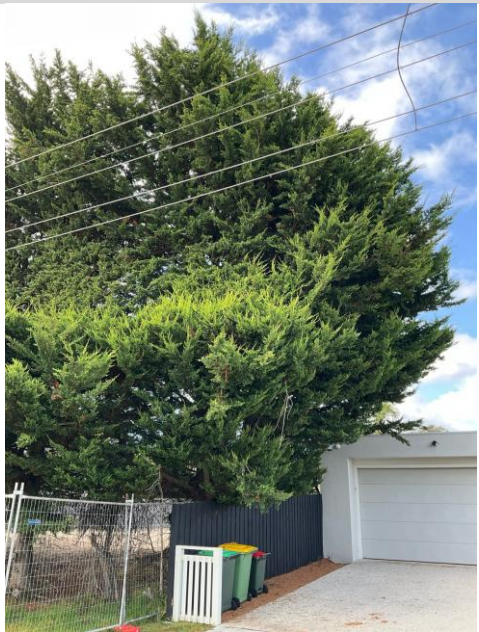
| Tree Number | | 7 | Medium Retention Value |

| Tree Number | | 7 | Medium Retention Value |
|---|--|---|---|
| Genus/Species | | <i>Cupressus macrocarpa</i> | |
| Common Name | | Monterey Cypress | |

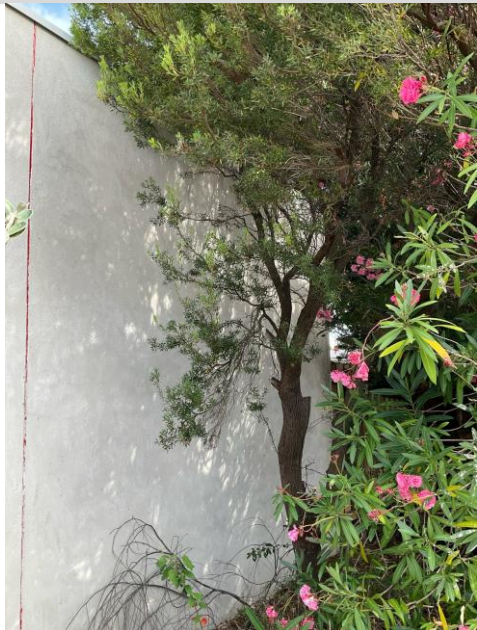
| Tree Number | | 9 | Medium Retention Value |

| Tree Number | | 9 | Medium Retention Value |
|---|---|---|---|
| Genus/Species | Leucopogon parviflorus | | |
| Common Name | Coast Beard-heath | | |
| Nominated for removal. | | | |

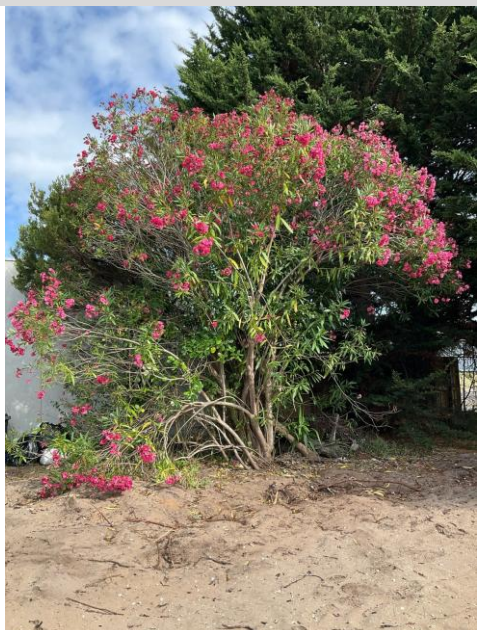
| Tree Number | | 10 | Low Retention Value |

| Tree Number | | 10 | Low Retention Value |
|---|---|---|---|
| Genus/Species | Nerium oleander | | |
| Common Name | Oleander | | |
| Nominated for removal. | | | |

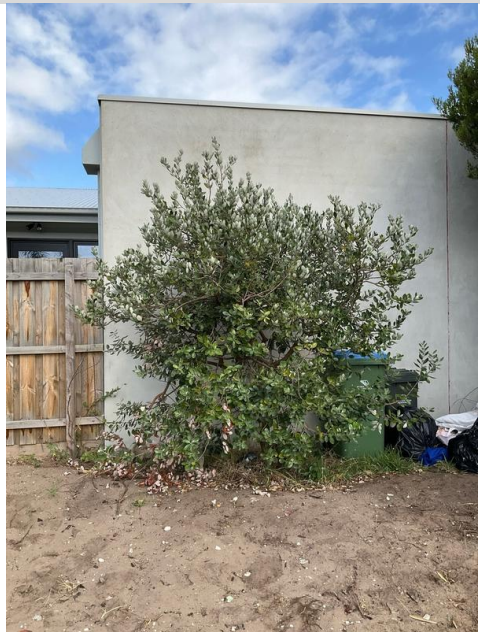
| Tree Number | | 11 | Low Retention Value |

| Tree Number | | 11 | Low Retention Value |
|---|--|---|---|
| Genus/Species | | <i>Feijoa sellowiana</i> | |
| Common Name | | Pineapple Guava | |
| Nominated for removal. | | | |

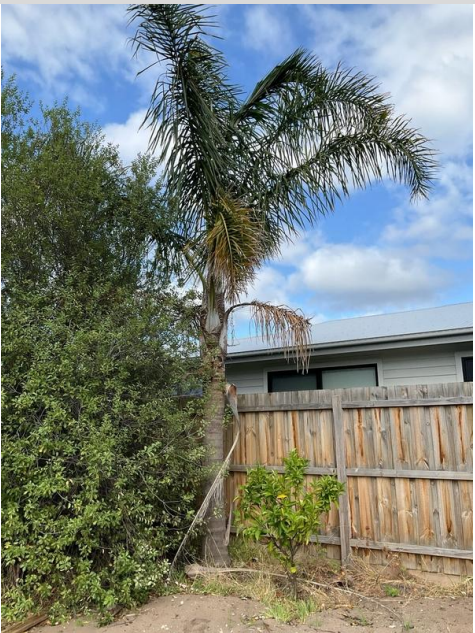
| Tree Number | | 12 | Low Retention Value |

| Tree Number | | 12 | Low Retention Value |
|---|--|---|---|
| Genus/Species | | <i>Arecastrum romanzoffianum</i> | |
| Common Name | | Queen Palm | |
| Nominated for removal. | | | |

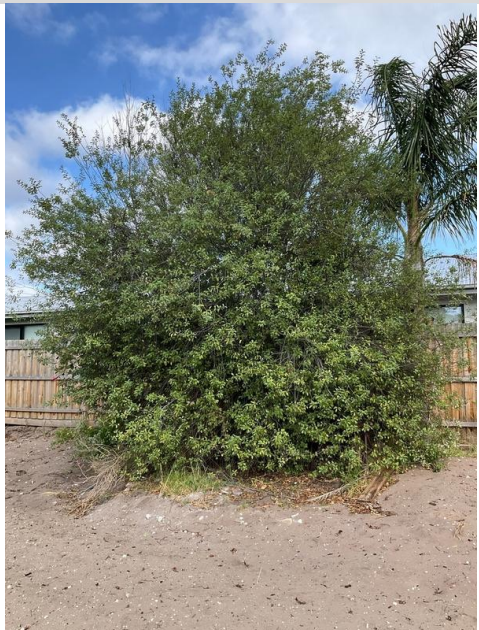
| Tree Number | | 13 | Low Retention Value |

| Tree Number | | 13 | Low Retention Value |
|---|--|---|---|
| Genus/Species | | <i>Pittosporum tenuifolium</i> 'James Stirling' | |
| Common Name | | James Stirling Pittosporum | |
| Nominated for removal. | | | |

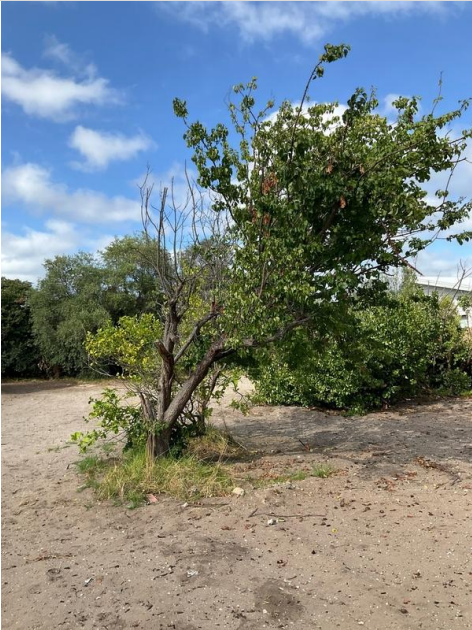
| Tree Number | | 14 | Low Retention Value |

| Tree Number | | 14 | Low Retention Value |
|---|---|---|---|
| Genus/Species | Pyrus communis | | |
| Common Name | Common Pear | | |
| Nominated for removal. | | | |

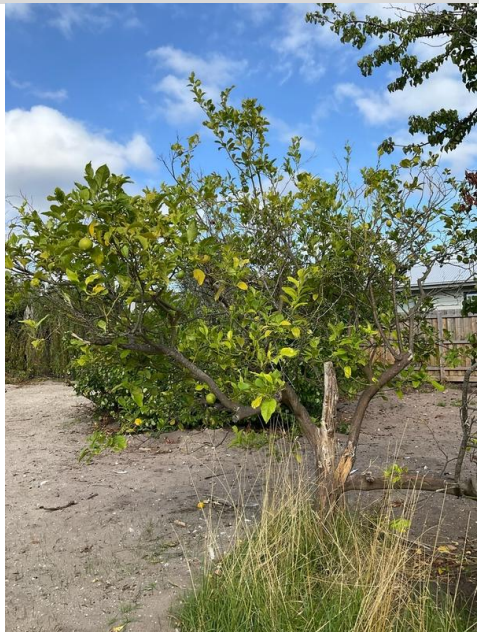
| Tree Number | | 15 | Low Retention Value |

| Tree Number | | 15 | Low Retention Value |
|---|--|---|---|
| Genus/Species | | <i>Citrus limon</i> | |
| Common Name | | Lemon | |
| Nominated for removal. | | | |

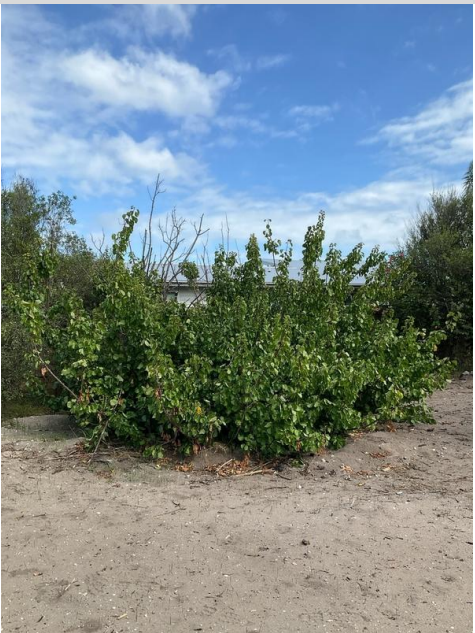
| Tree Number | | 16 | Low Retention Value |

| Tree Number | | 16 | Low Retention Value |
|---|--|---|---|
| Genus/Species | | <i>Pyrus communis</i> | |
| Common Name | | Common Pear | |
| Nominated for removal. | | | |

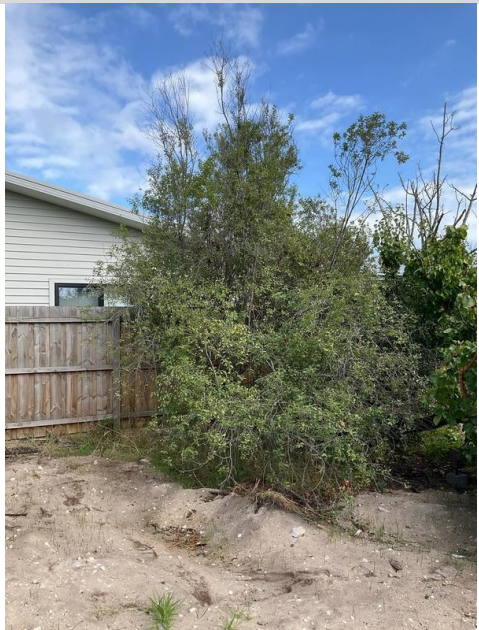
| Tree Number | | 17 | Low Retention Value |

| Tree Number | | 17 | Low Retention Value |
|---|--|---|---|
| Genus/Species | | <i>Pittosporum tenuifolium</i> 'James Stirling' | |
| Common Name | | James Stirling Pittosporum | |

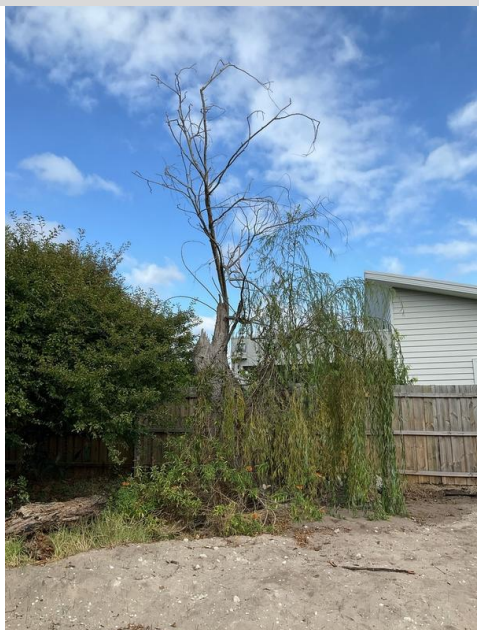
| Tree Number | | 18 | Low Retention Value |

| Tree Number | | 18 | Low Retention Value |
|---|--|---|---|
| Genus/Species | | <i>Salix babylonica</i> | |
| Common Name | | Babylon Weeping Willow | |
| Structure | | Hazardous | |

| Tree Number | | 18 | Low Retention Value |
|---|--|---|---|
| Nominated for removal. | | | |

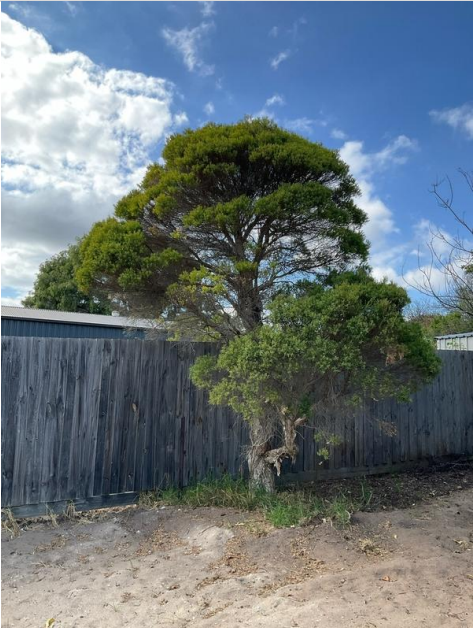
| Tree Number | | 19 | Medium Retention Value |

| Tree Number | | 19 | Medium Retention Value |
|---|---|---|---|
| Genus/Species | Melaleuca linariifolia | | |
| Common Name | Snow In Summer | | |
| No developmental impact. | | | |

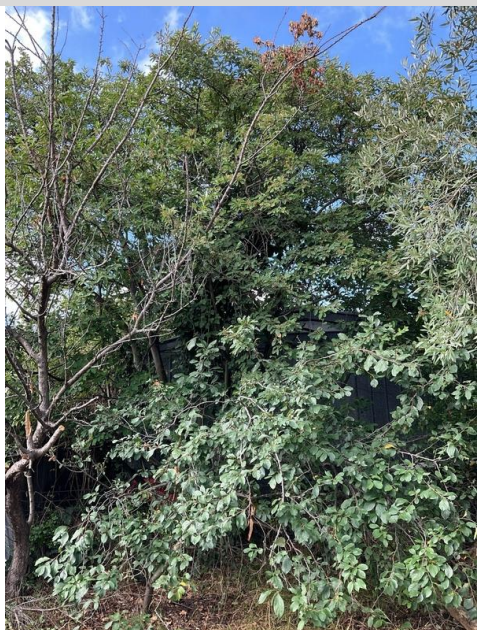
| Tree Number | | 20 | Low Retention Value |

| Tree Number | | 20 | Low Retention Value |
|---|--|---|---|
| Genus/Species | | <i>Cotoneaster glaucophyllus</i> | |
| Common Name | | Cotoneaster | |
| No developmental impact. | | | |

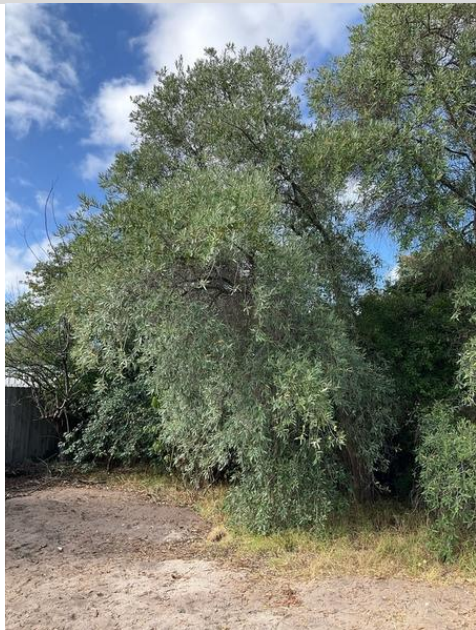
| Tree Number | | 21 | Low Retention Value |

| Tree Number | | 21 | Low Retention Value |
|---|---|---|---|
| Genus/Species | Olea europaea | | |
| Common Name | European Olive | | |
| No developmental impact. | | | |

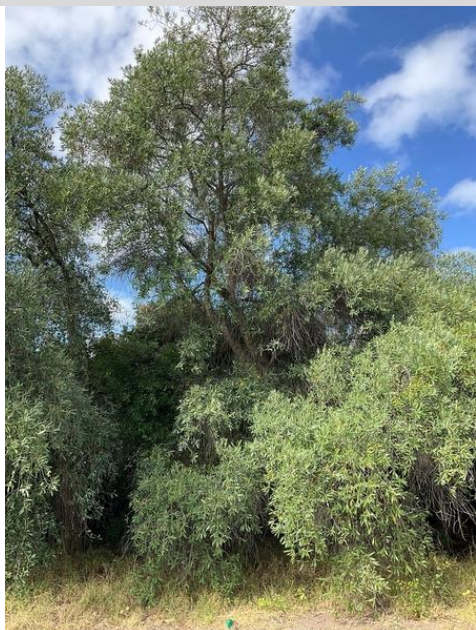
| Tree Number | | 22 | Low Retention Value |

| Tree Number | | 22 | Low Retention Value |
|---|---|---|---|
| Genus/Species | Olea europaea | | |
| Common Name | European Olive | | |
| No developmental impact. | | | |

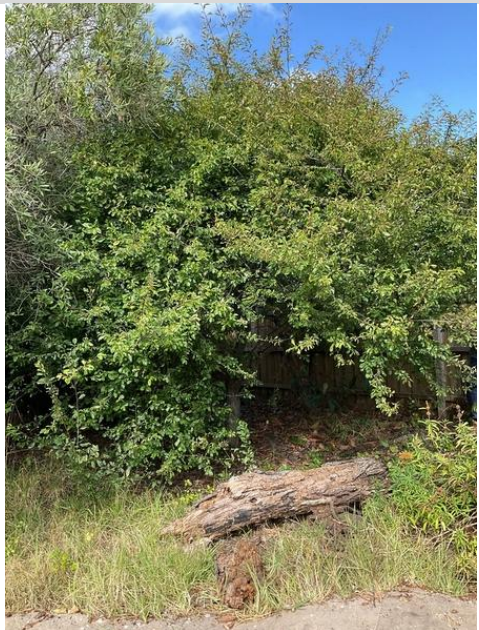
| Tree Number | | 23 | Low Retention Value |

| Tree Number | | 23 | Low Retention Value |
|---|---|---|---|
| Genus/Species | Prunus cerasifera | | |
| Common Name | Cherry Plum | | |
| No developmental impact. | | | |

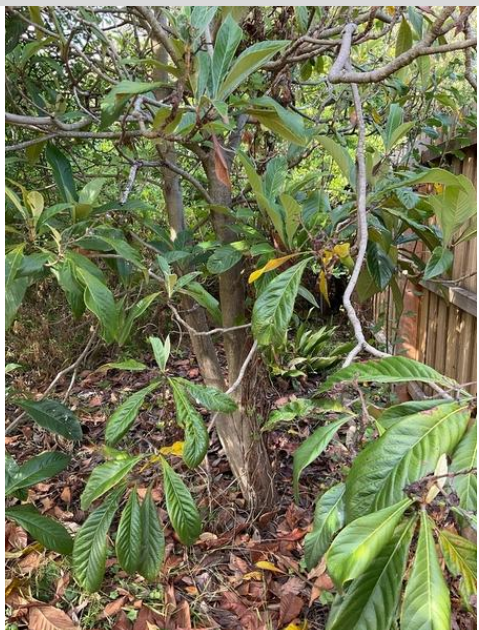
| Tree Number | | 24 | Low Retention Value |

| Tree Number | | 24 | Low Retention Value |
|---|---|---|---|
| Genus/Species | Eriobotrya sp. | | |
| Common Name | Loquat | | |

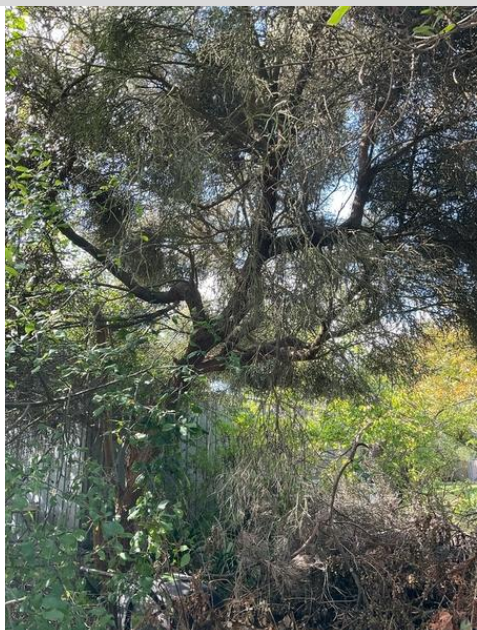
| Tree Number | | 26 | High Retention Value |

| Tree Number | | 26 | High Retention Value |
|---|---|---|---|
| Genus/Species | Melaleuca lanceolata | | |
| Common Name | Moonah | | |

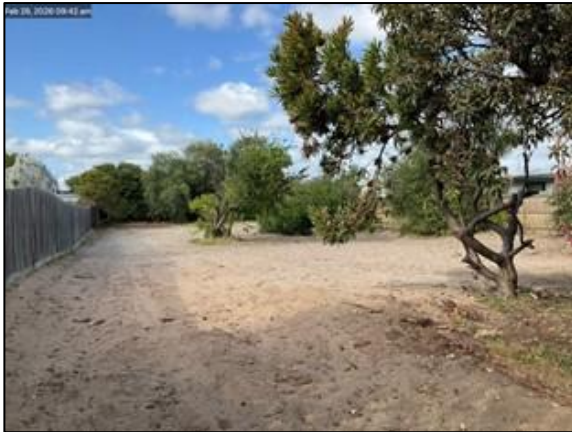
*Photo 1. View of the site from its frontage, looking south.*

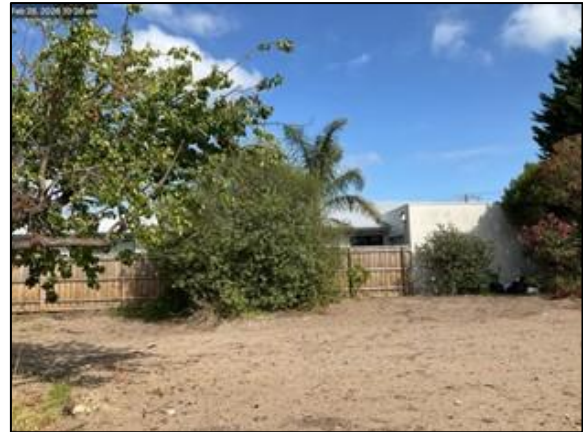
*Photo 2. View from near the centre of the site looking west towards the existing residence at 7 The Glen.*

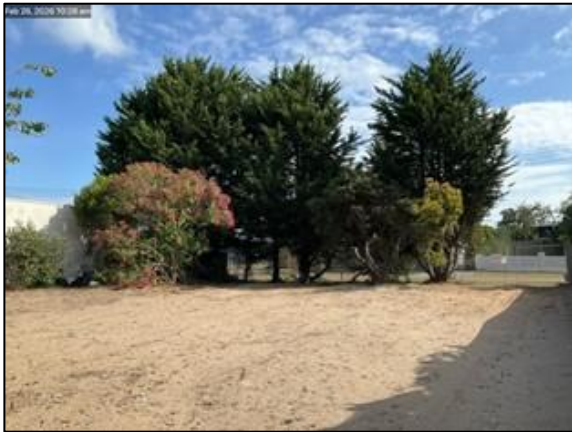
*Photo 3. View of the front section of the site looking north towards The Glen.*

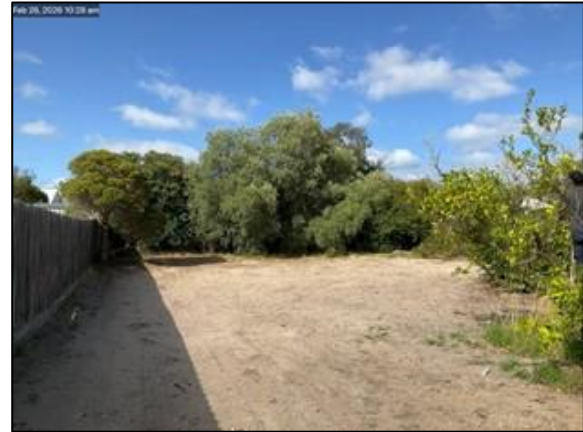
*Photo 4. View from midway along the site looking south.*

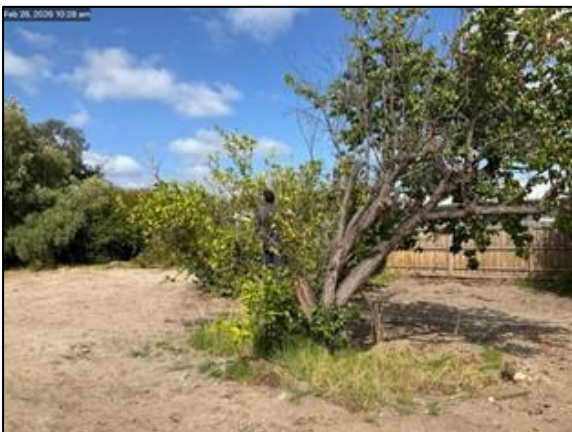
*Photo 5. View from the midway point of the site looking west with existing low retention Tree 15 at centre of photo.*
